June 28, 2017

**Subject:   *Seismic Assessment of the South Emergency Operations Center***  
***26081 Via Pera, Mission Viejo, CA 92691***  
IDS Job Number: 17S020

Per your request, IDS Group, Inc. (IDS) has performed a seismic assessment of the South Emergency Operations Center (EOC) for the Water Emergency Response Organization of Orange County (WEROC) located at 26081 Via Pera in Mission Viejo, California. This letter presents our opinions, observations, and conclusions based upon our assessment.

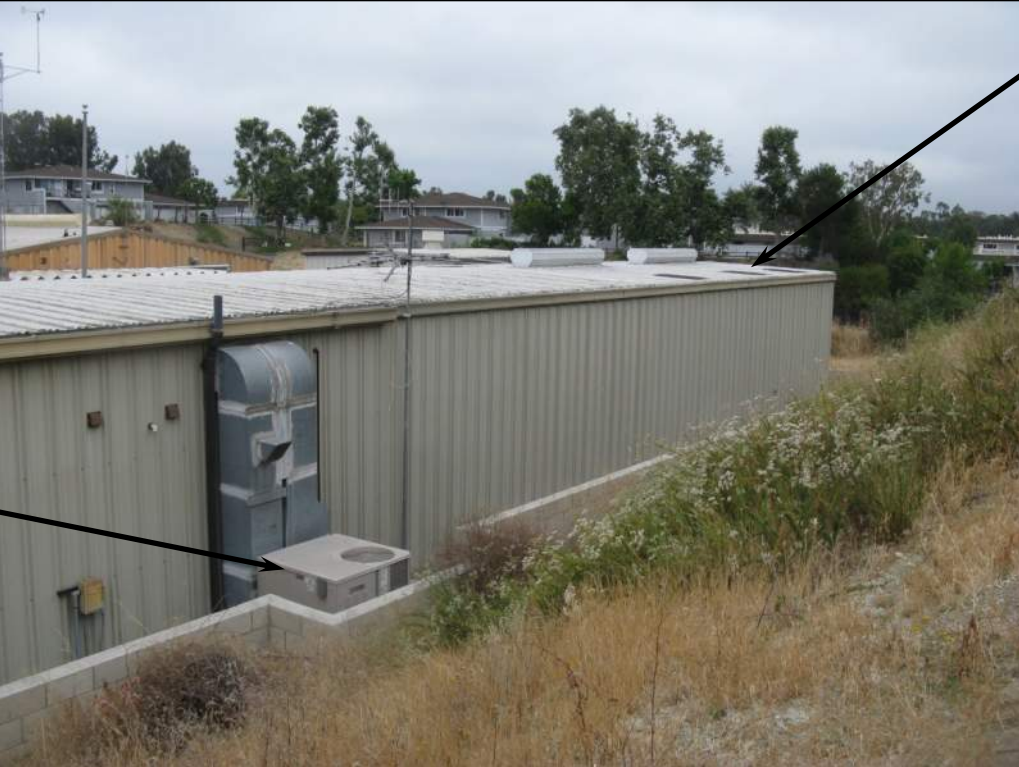
Photo 4: West Side of Building (View toward South End)

- Roof Panel Deterioration – Several locations of roof panel deterioration and damage were observed. At the south end of the building, six areas of apparent prior repairs were observed [Photos 4 and 7 to 10]. These areas are regularly spaced toward the outside edges of the building and are approximately 3 feet by 4 feet in size. Additionally, several locations toward the northwest corner of the building were observed having small areas of efflorescence and corrosion on the underside of the roof panels [Photo 21]. The efflorescence and corrosion areas in these locations were generally smaller than 1 foot square.

Roof Panel  
Damage  
See Photos  
7 to 10

5. Repair Damaged or Deteriorated Building Elements – Where damage or deterioration exists, we recommend repairing the elements to prevent or reduce future or ongoing damage and deterioration.

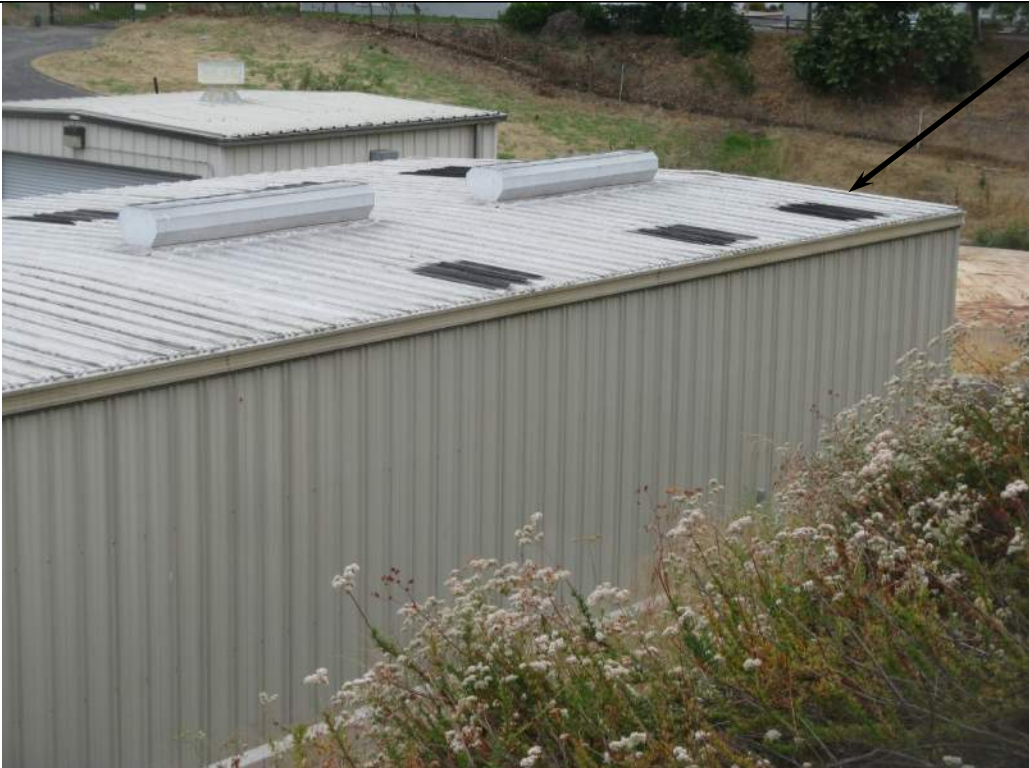
**Photo 7: West Side of Building (View Toward South End)**

Apparent  
Damage  
Repair at  
Roof  
Panel  
(See  
Photo  
10)

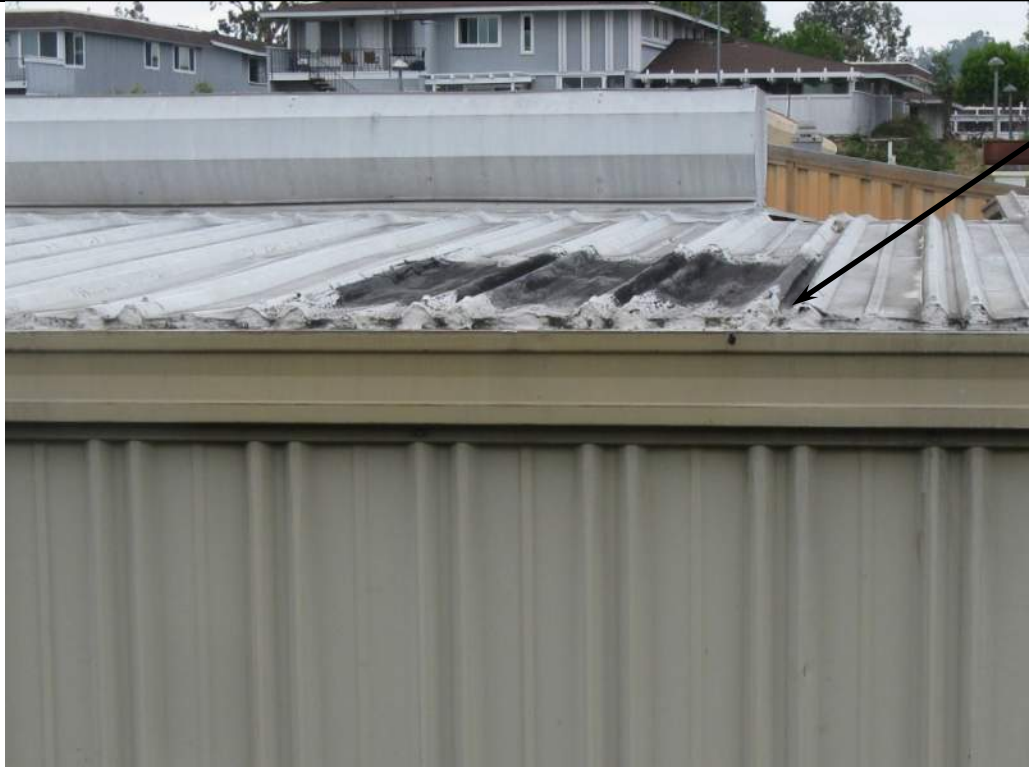
**Photo 8: Close-up of Roof Repair at West Side**

Roofing  
Sealants  
Applied

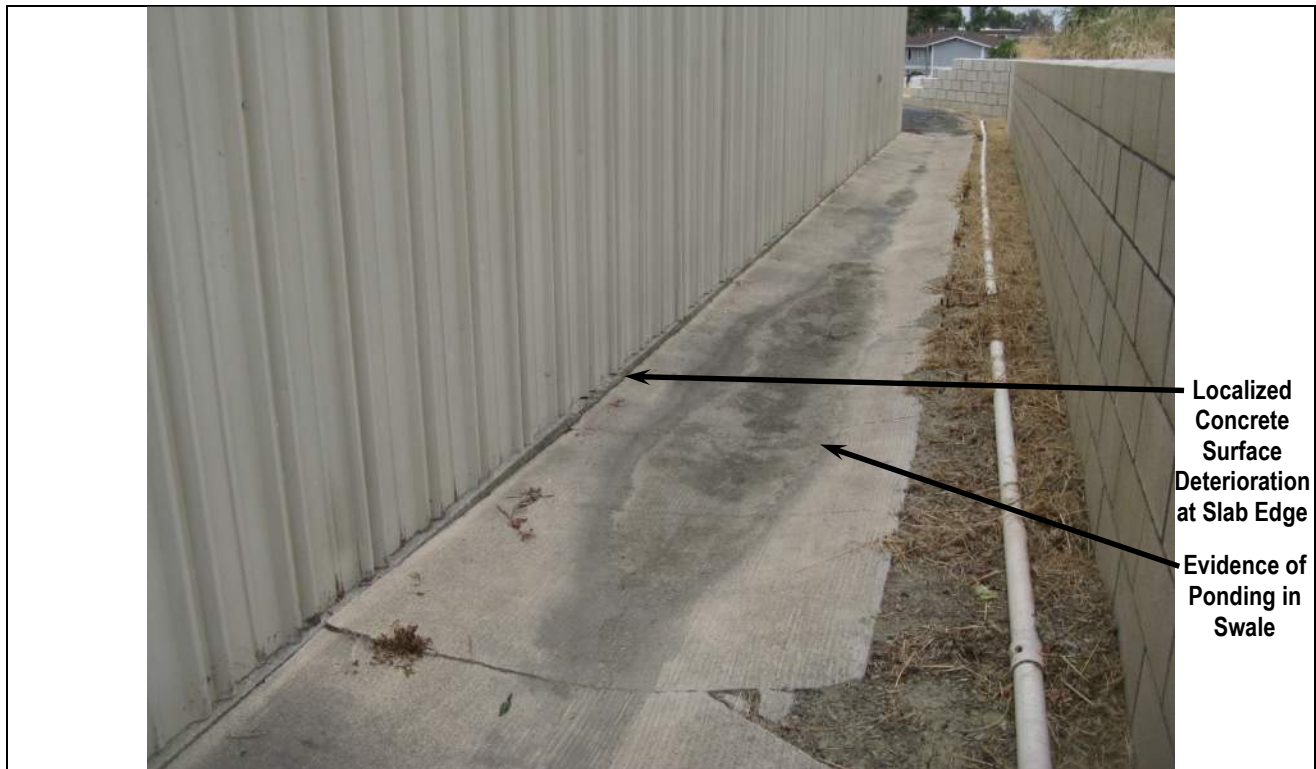
**Photo 11: View Along West Side of Building**

- Concrete Slab Damage – The majority of the concrete slab on grade was covered by carpeting or other floor finishes and so was not open to view. However, the slab in the garage area at the south end of the building was bare and open to view. In this area, we observed some linear cracking that did not appear unusual for slabs of this type with its existing joint spacing [Photo 15]. We also observed one location at the front of the garage where the concrete slab has cracked between the door jamb anchors and the slab edge [Photo 12]. A small area (approximately 2 feet long) of deterioration of an exposed slab edge on the west side of the building was also observed. The corner of the concrete in this area appears to

have eroded away, however the exposed aggregate appeared to be firmly embedded and the concrete paste appeared sound [Photo 11].

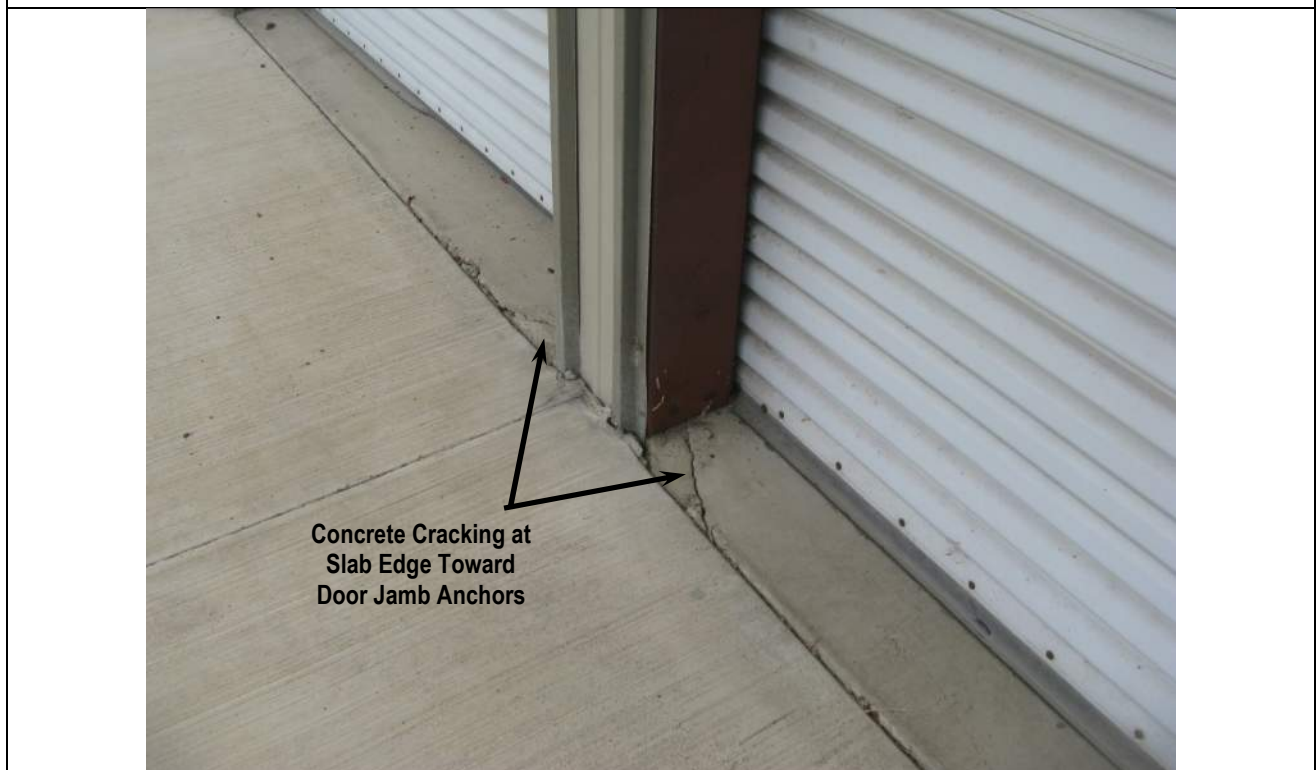
**Photo 12: Damaged Concrete at Slab Edge**

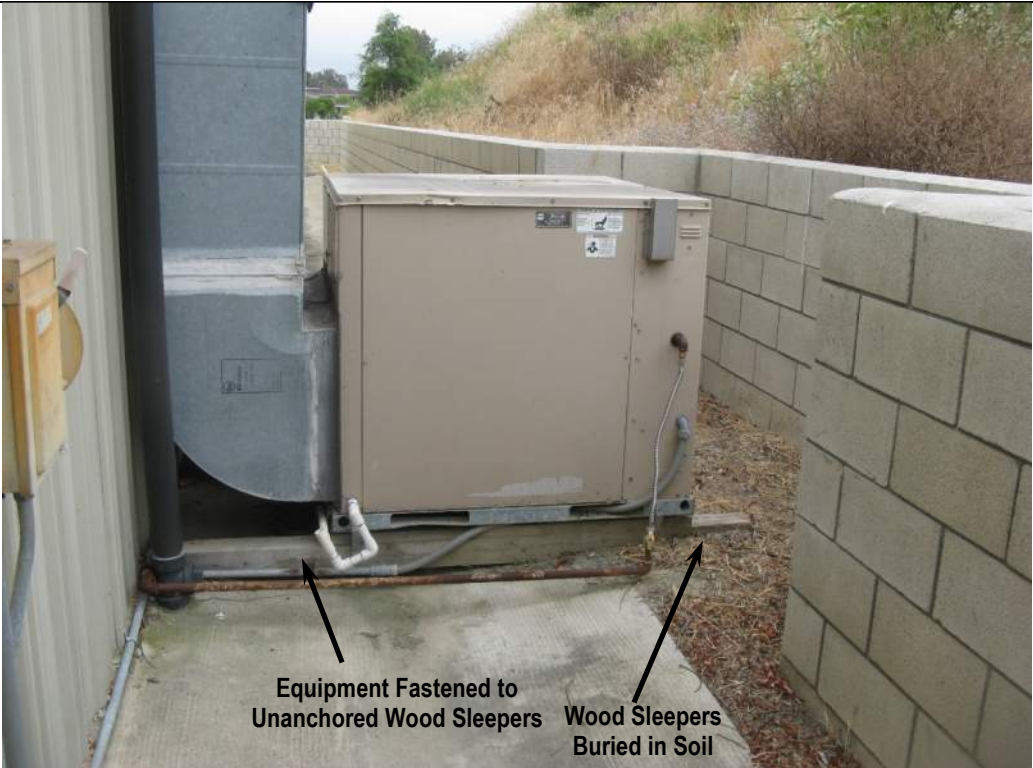
**Photo 13: Mechanical Equipment at West Side**

- Exterior Mechanical Equipment Not Anchored – A single mechanical unit exists on the west side of the building [Photos 13 and 14]. This unit is resting on two 4x4 sleepers, and has a flexible natural gas line, but is inadequately anchored for seismic forces.

4. Anchor Non-Structural Elements and Equipment – Anchorage and bracing of non-structural elements and equipment is necessary to prevent or reduce falling objects and potential damage to equipment necessary for emergency operations.

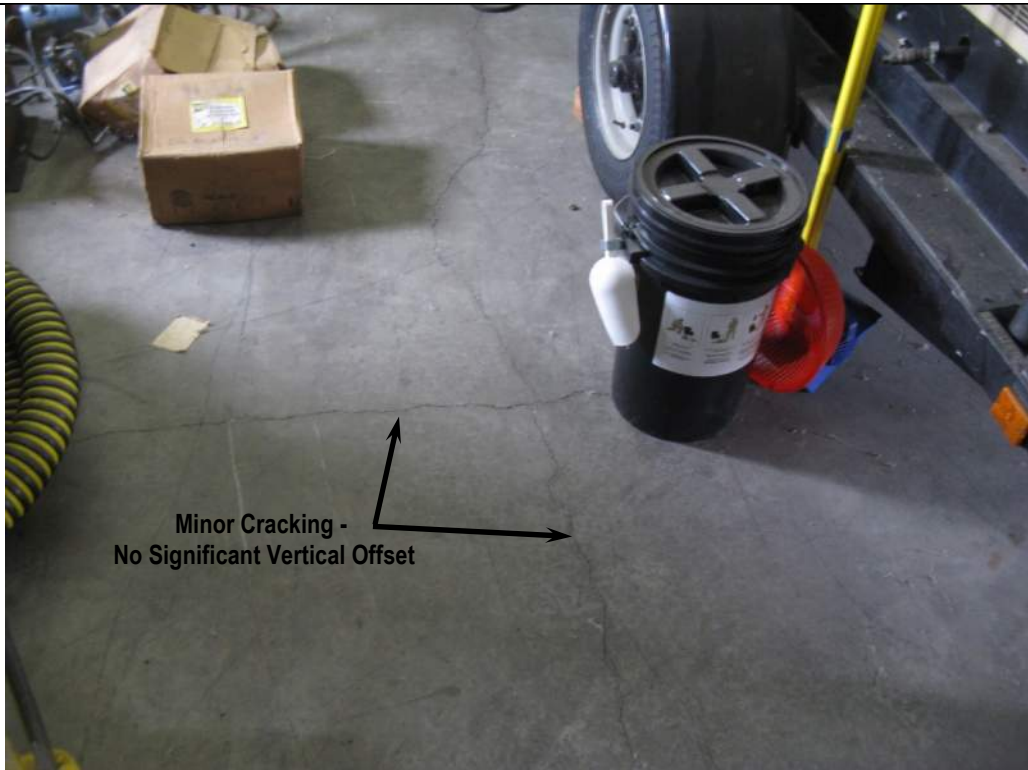
**Photo 15: Cracking at Concrete Slab in Garage**

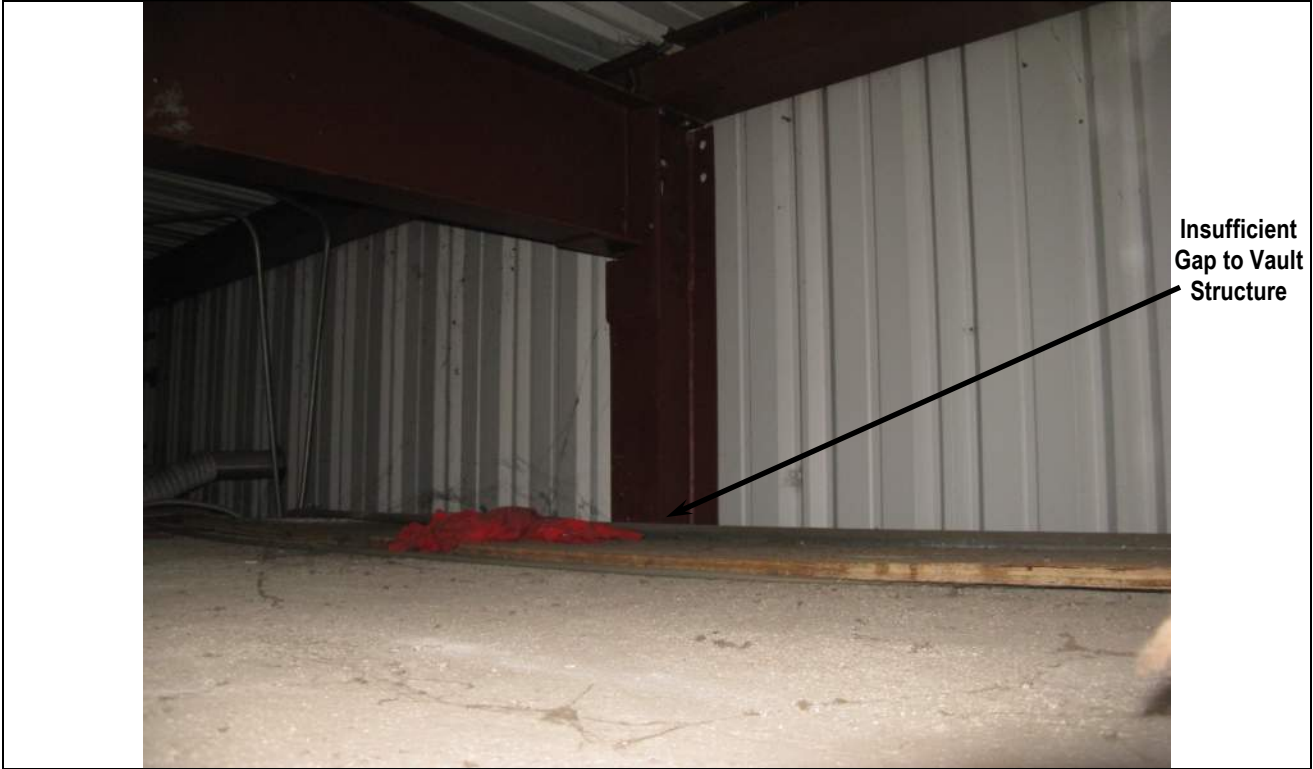
- Adjacent Structures– The concrete masonry vault structure inside the building is located adjacent to the first interior frame from the building's north end. There is insufficient gap between these two elements to prevent unintended interaction [Photo 18].

**Photo 18: Rigid Frame Abutting Masonry Vault**

3. Provide Seismic Separation at Masonry Vault – The masonry vault is a rigid element that will have almost no seismic movement relative to the surrounding building frame. Adequate separation of these elements is necessary to prevent damage to the building frame system.

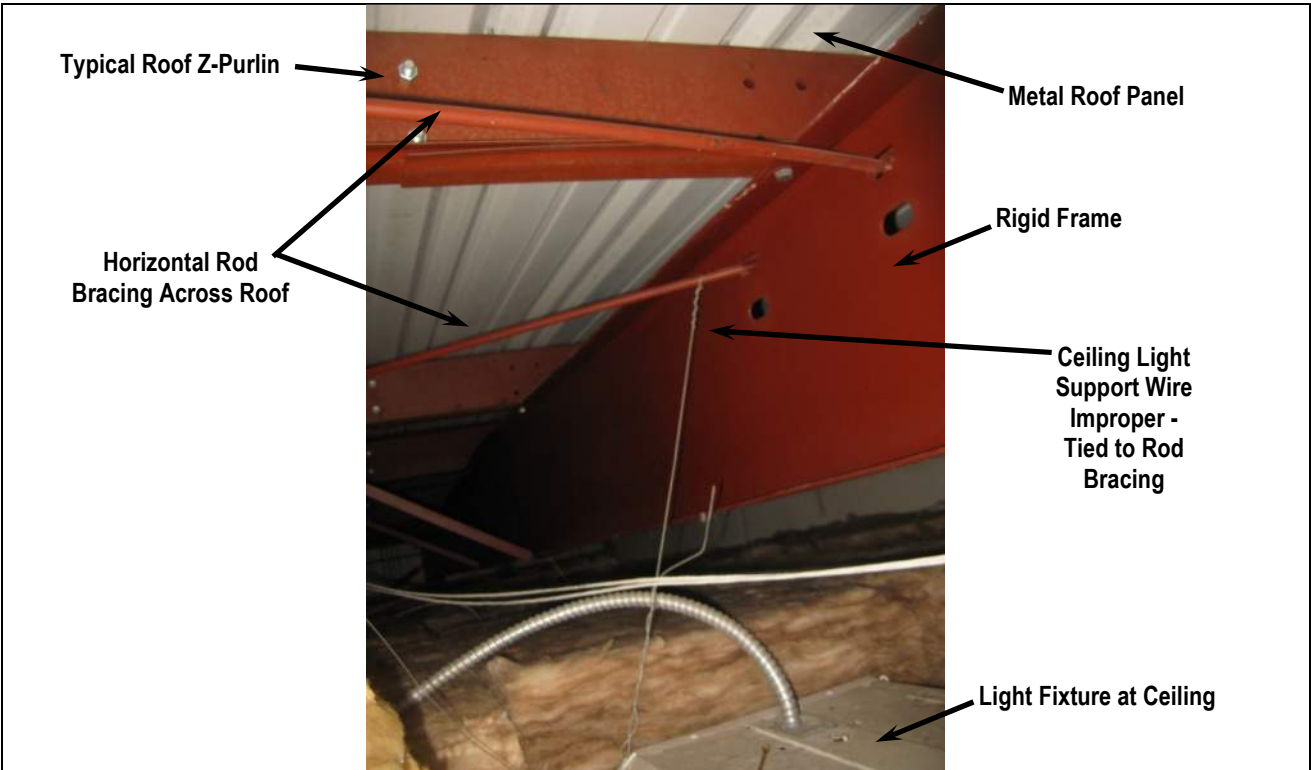
**Photo 19: View of Above Ceiling**

- Non-compliant Ceiling – The ceilings were observed to be supported and braced with undersized wires (0.0625-inch diameter instead of 0.106-inch diameter), to not have compression bracing, and to have wires without proper connections or wrapping. Perimeter ceiling support angles were also observed to be too small and irregularly anchored to

properly support the ceiling grid [Photos 19, 22 to 24]. The grid near the south exterior door to the EOC room was also observed to have several panels that were loose close to falling from the grid [Photo 27].

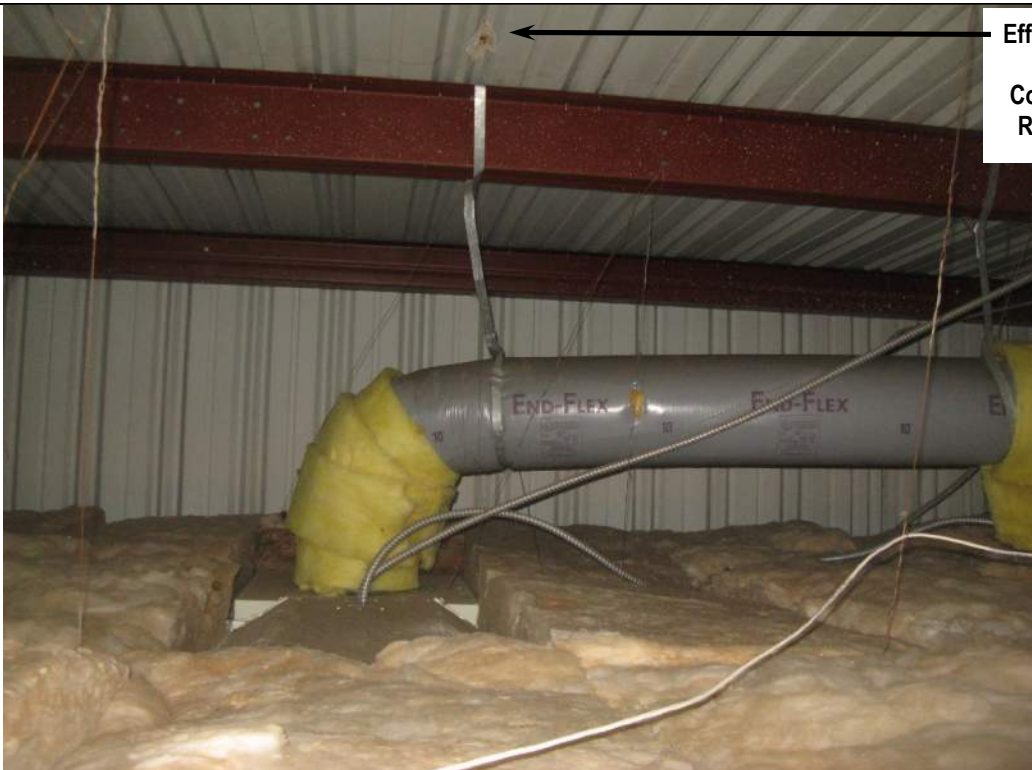
Photo 21: Typical View of Above Ceiling

No Compression  
Posts Present

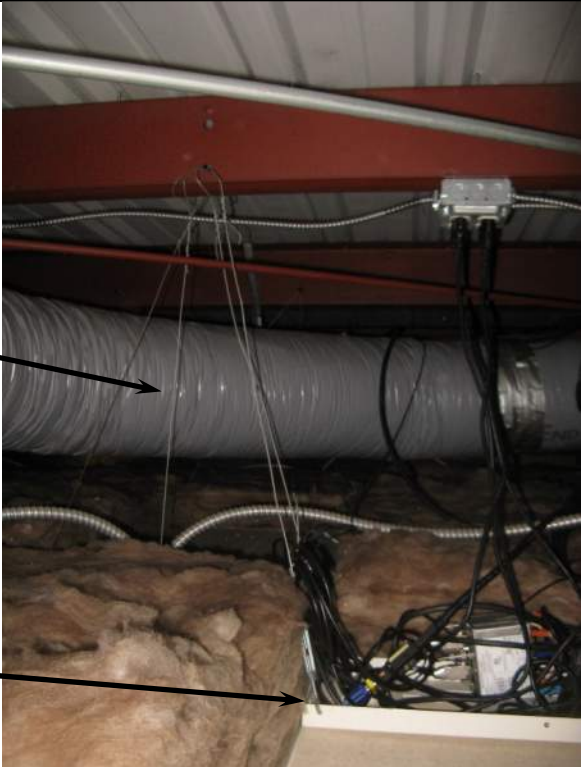
Photo 22: Ceiling at EOC Projector

- Non-compliant Finishes and Fixture Support and Bracing – In the office portion of the building, the suspended ceilings, lights, mechanical registers, and projector were identified to have non-compliant installation due to improper and undersized suspension and bracing wires, as well as lack of compression posts and proper edge detailing. These features are anticipated to lead to damage of these systems possibly including falling ceiling panels, lights, and fixtures.

Ceiling Mounted  
Projector – No Direct  
Support to Structure

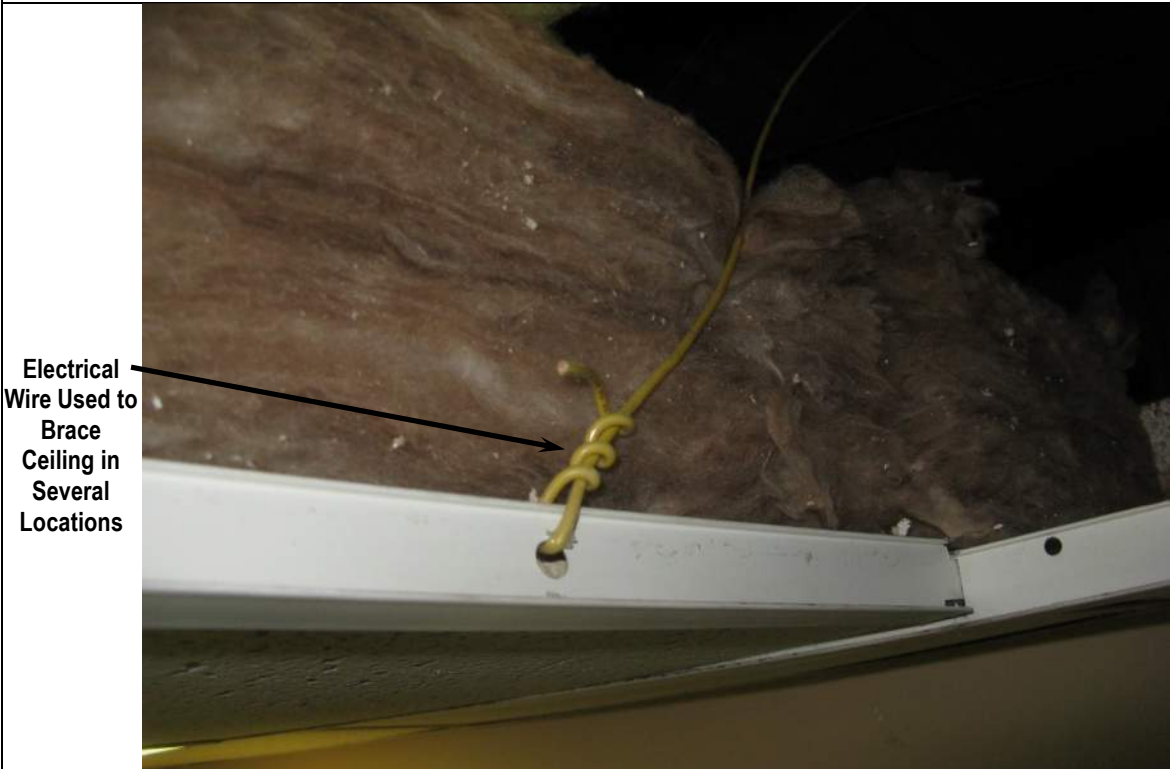
Photo 24: View of Improper Ceiling Support Wire

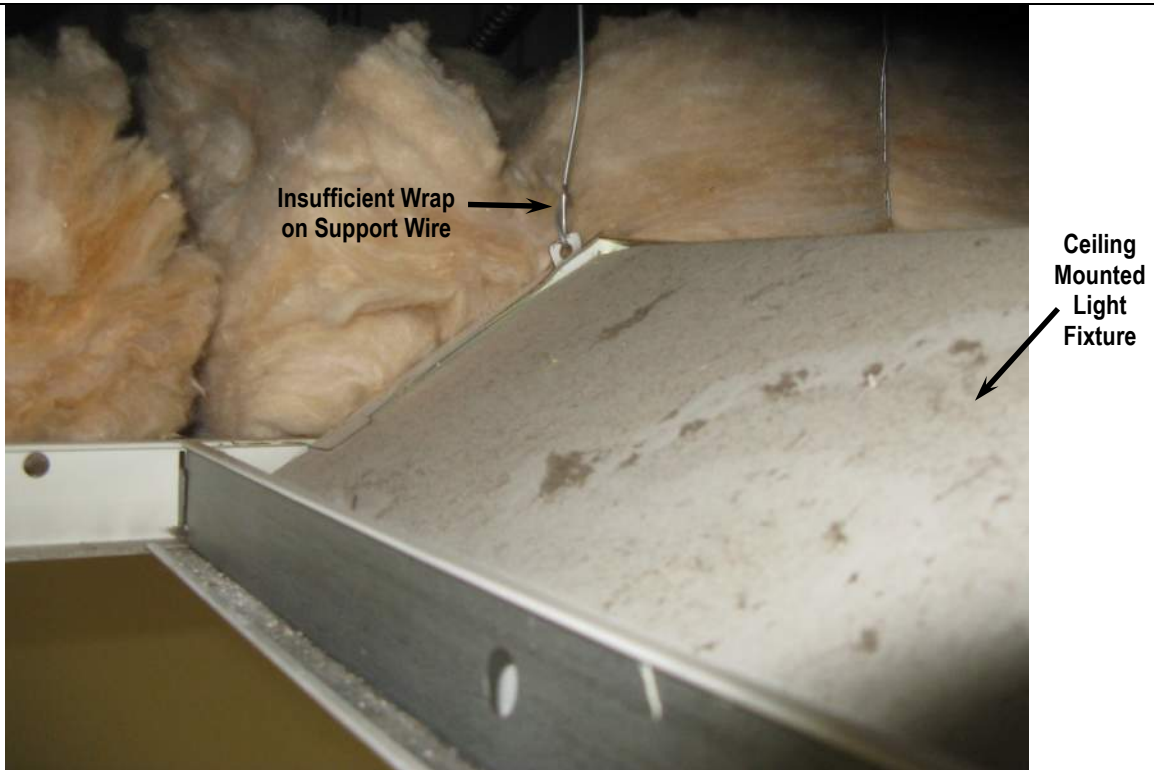
- Light Fixture Supplemental Support Wires Non-compliant – The light fixtures in the ceiling system were generally observed to have supplemental support wires at opposite corners of each fixture, but the wires were undersized (similar to the ceiling support wires) and were often improperly installed (also similar to the ceiling) [Photos 25 and 26].

**Photo 25: View of Improper Light Support Wire**

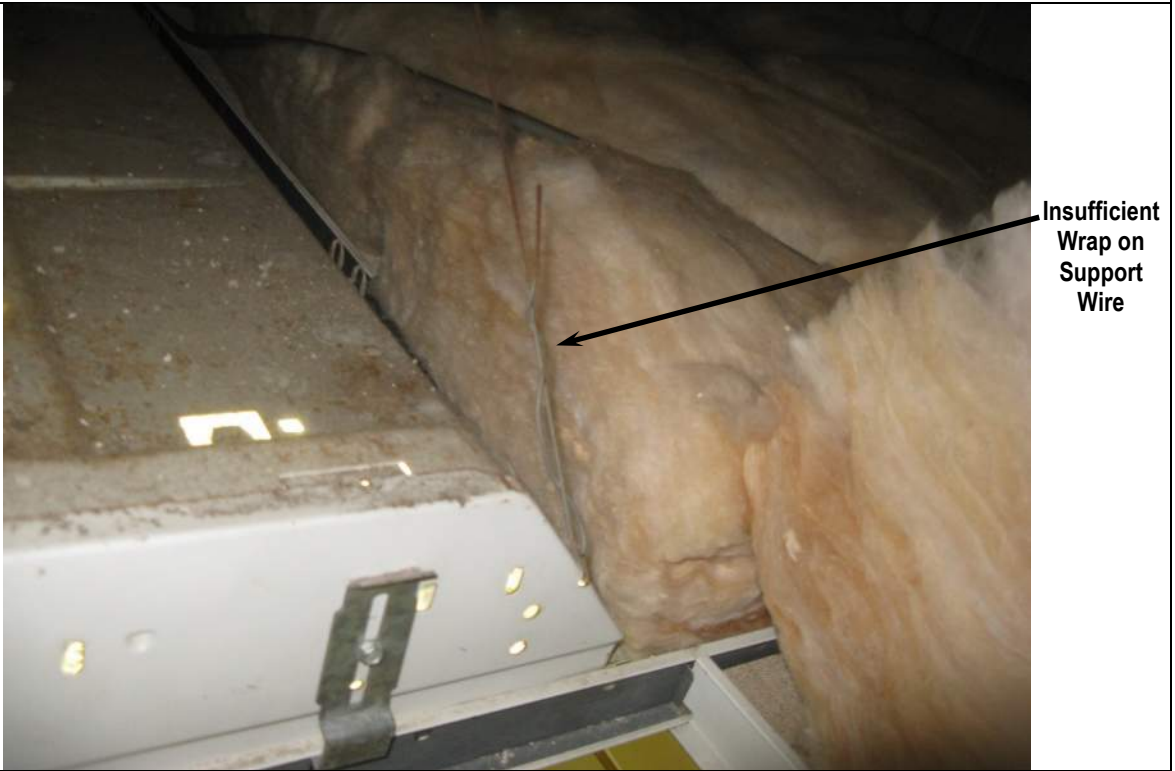
**Photo 26: View of Improper Light Support Wire**

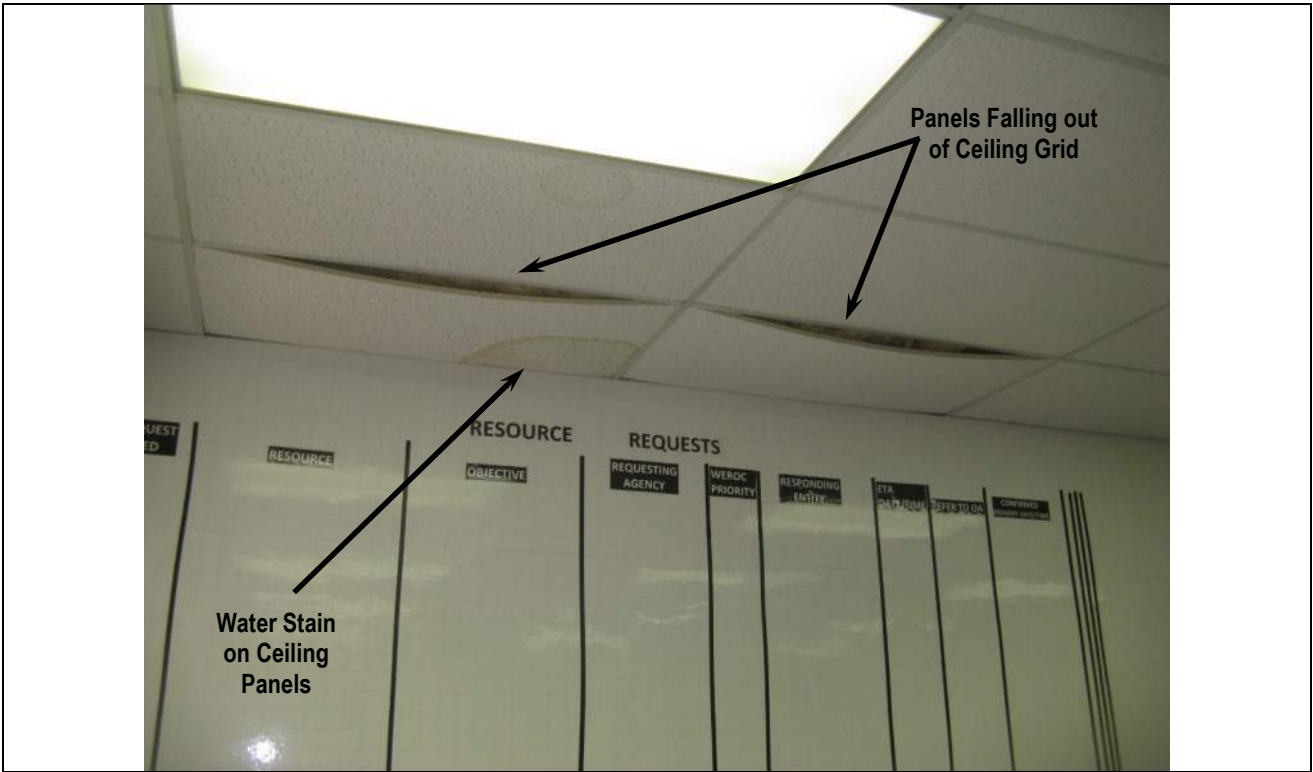
**Photo 27: Damage and Falling Panels Near Entrance/Exit**

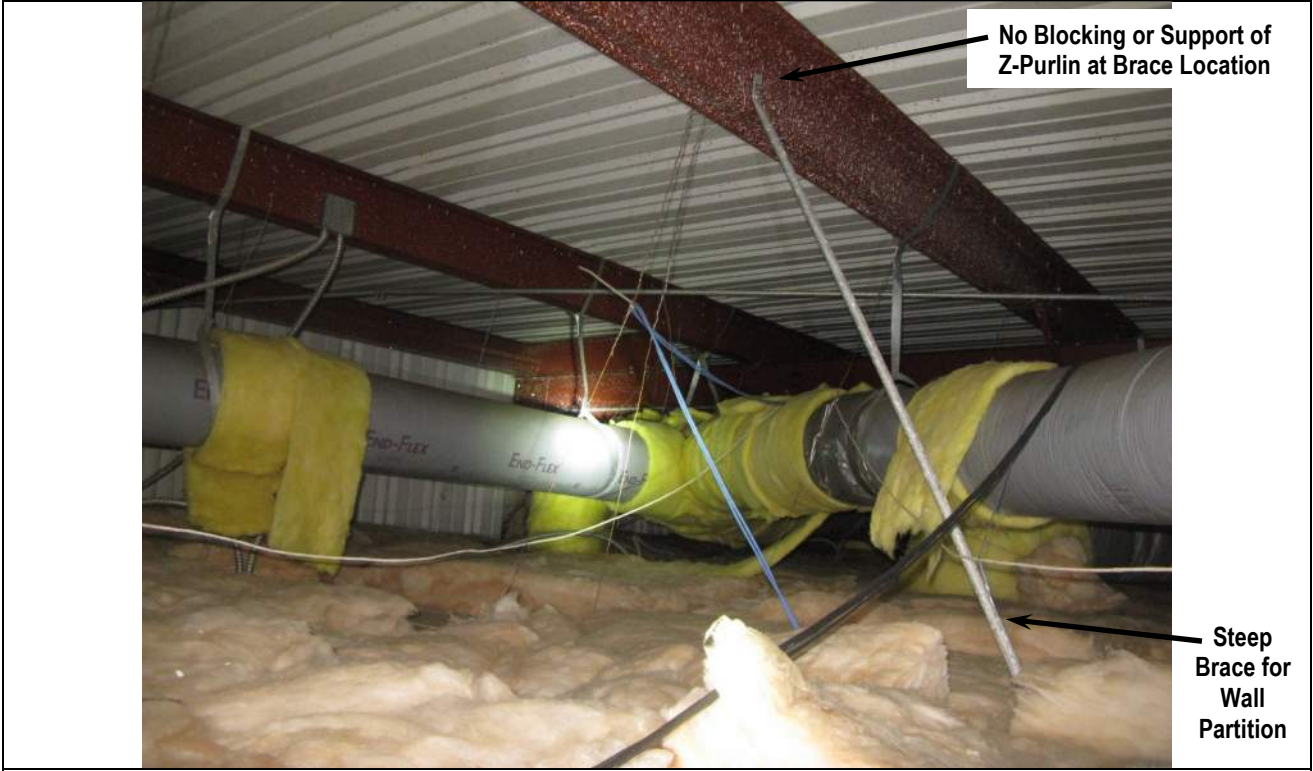
**Photo 28: Typical View within Ceiling Space**

- Interior Partition Bracing – Interior partitions were observed to have steep bracing to z-purlin members at locations without blocking or stability bracing. [Photos 28 and 29]. Along the perimeter of the building, the partitions appeared to be anchored and braced at their mid-height to the exterior wall wind girt members [Photo 30]. These partitions did not appear to have bracing at their top.

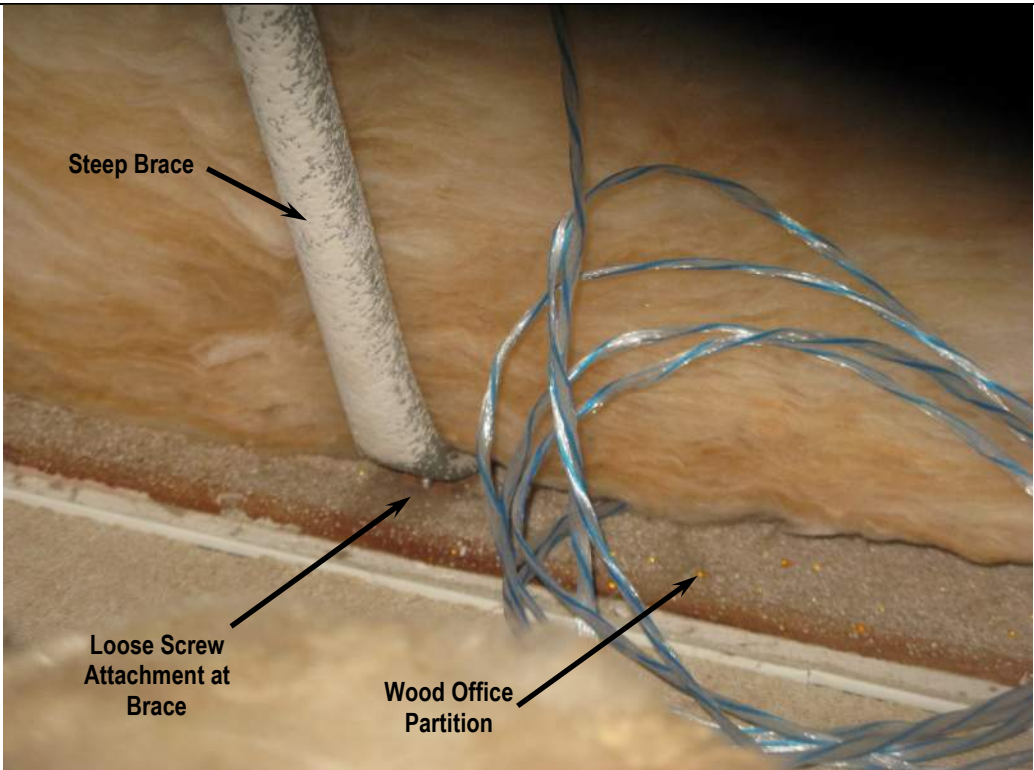
**Photo 29: Loose Attachment of Partition Braces**

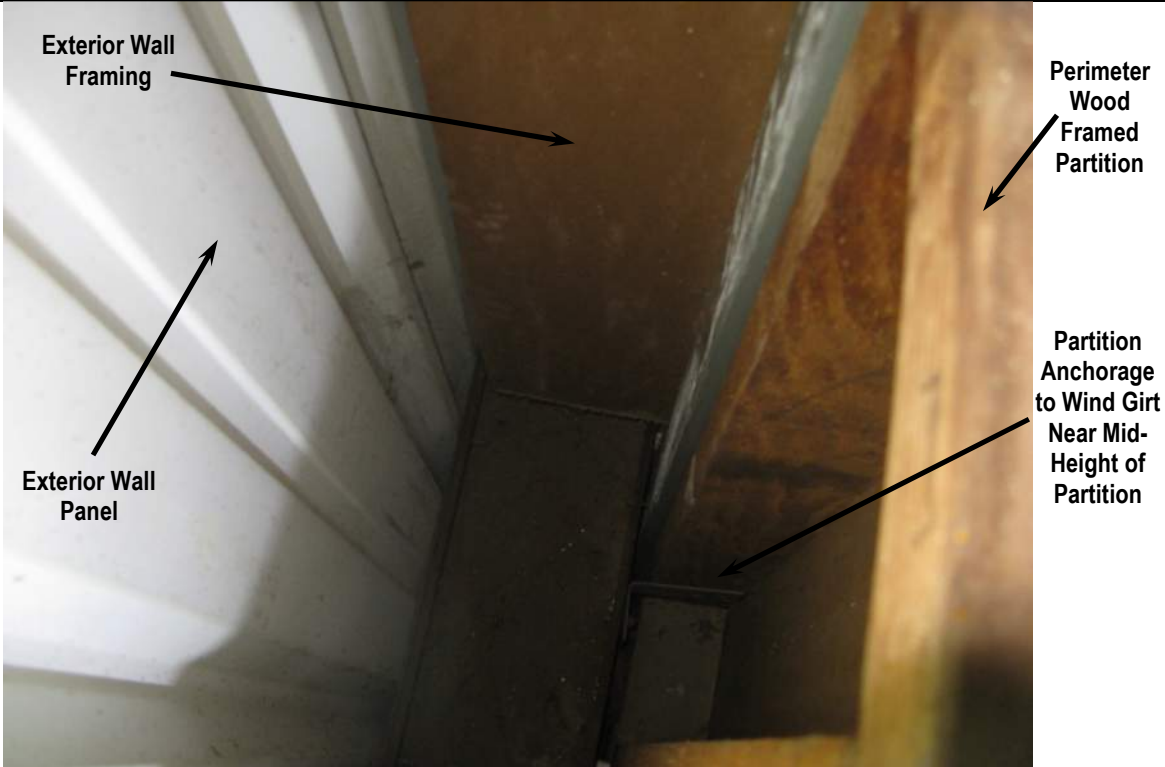
**Photo 30: View of Perimeter Partition Attachment (Looking Down)**

- Computer Equipment Not Anchored – Computer equipment presumed critical to the emergency operations was generally observed to have no seismic restraint or seismic straps and anchors that were not engaged [Photo 30]. Other equipment was also found to have no anchors or straps [Photos 31 to 35].

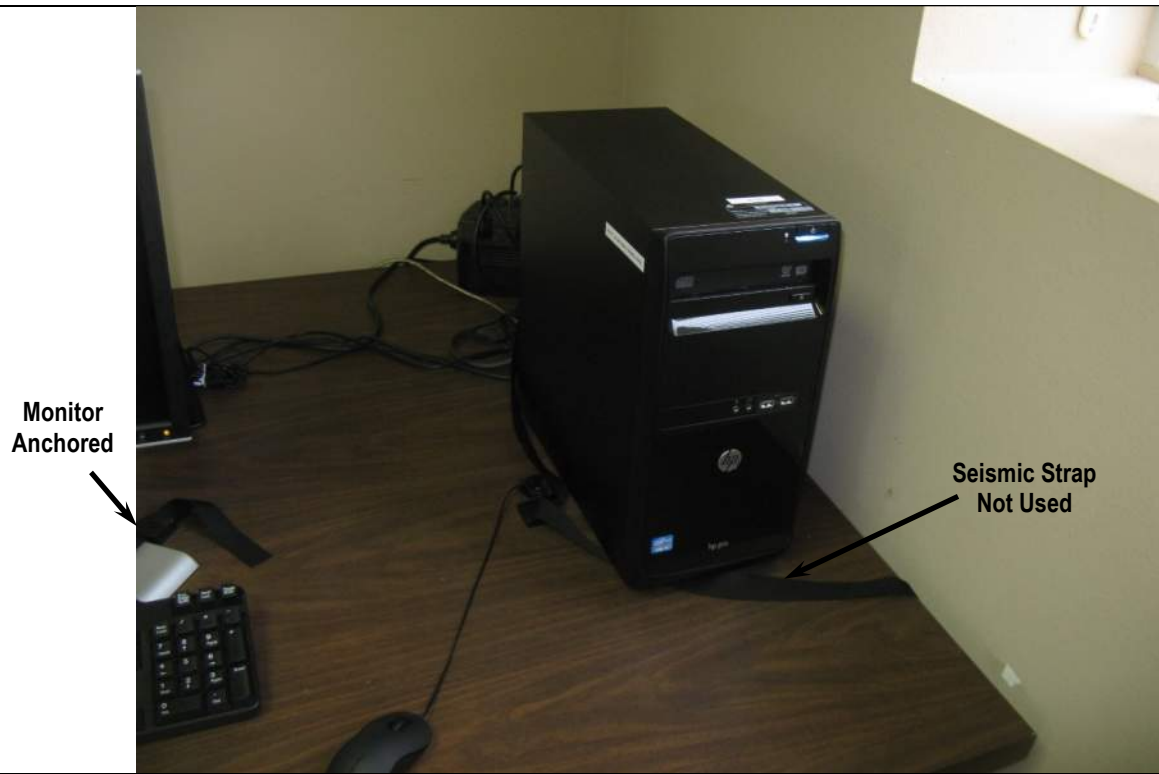
**Photo 32: Unanchored Computer Equipment**

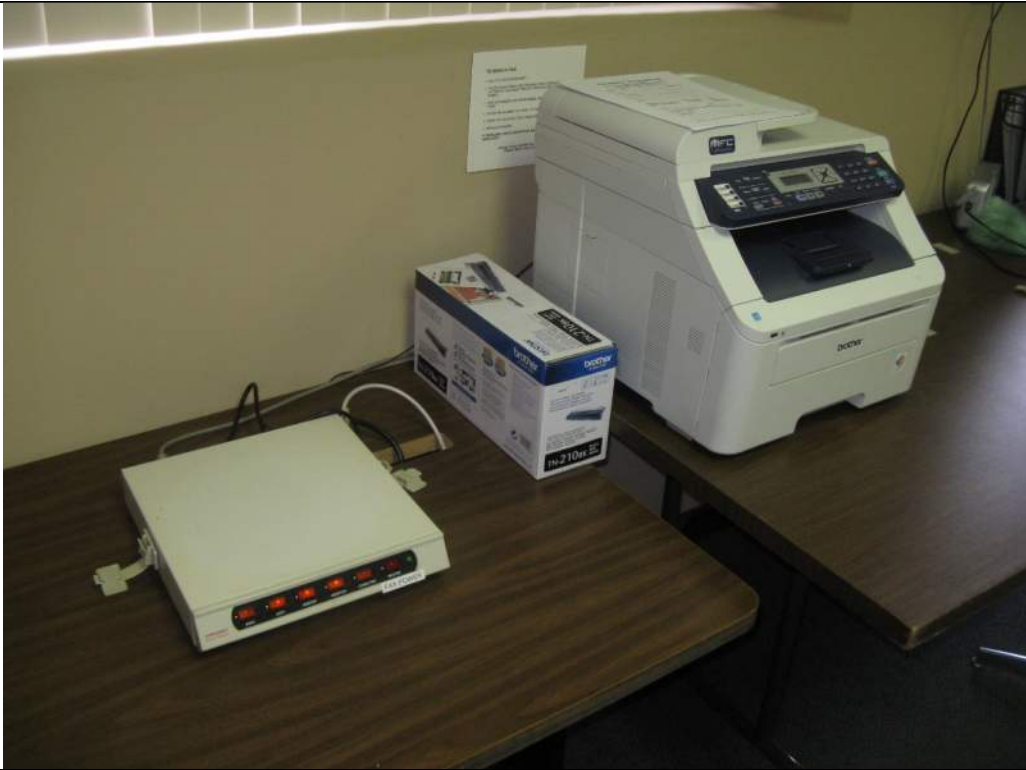
**Photo 33: Unanchored Computer Equipment**

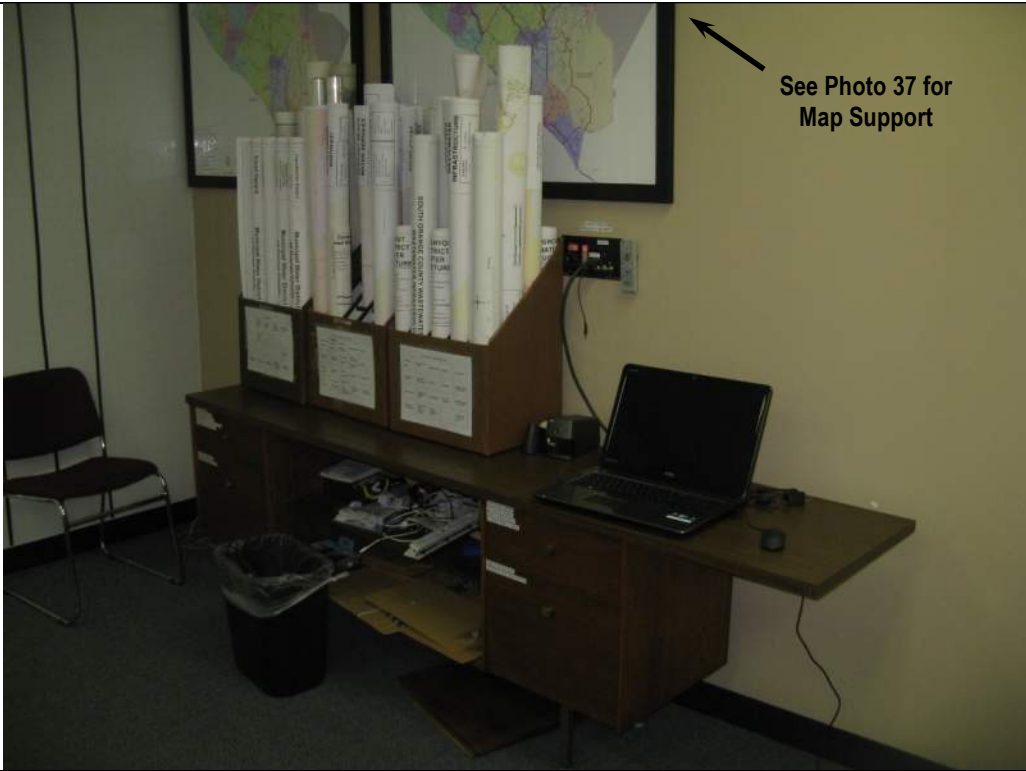
**Photo 34: Unanchored Computer Equipment & Documents**

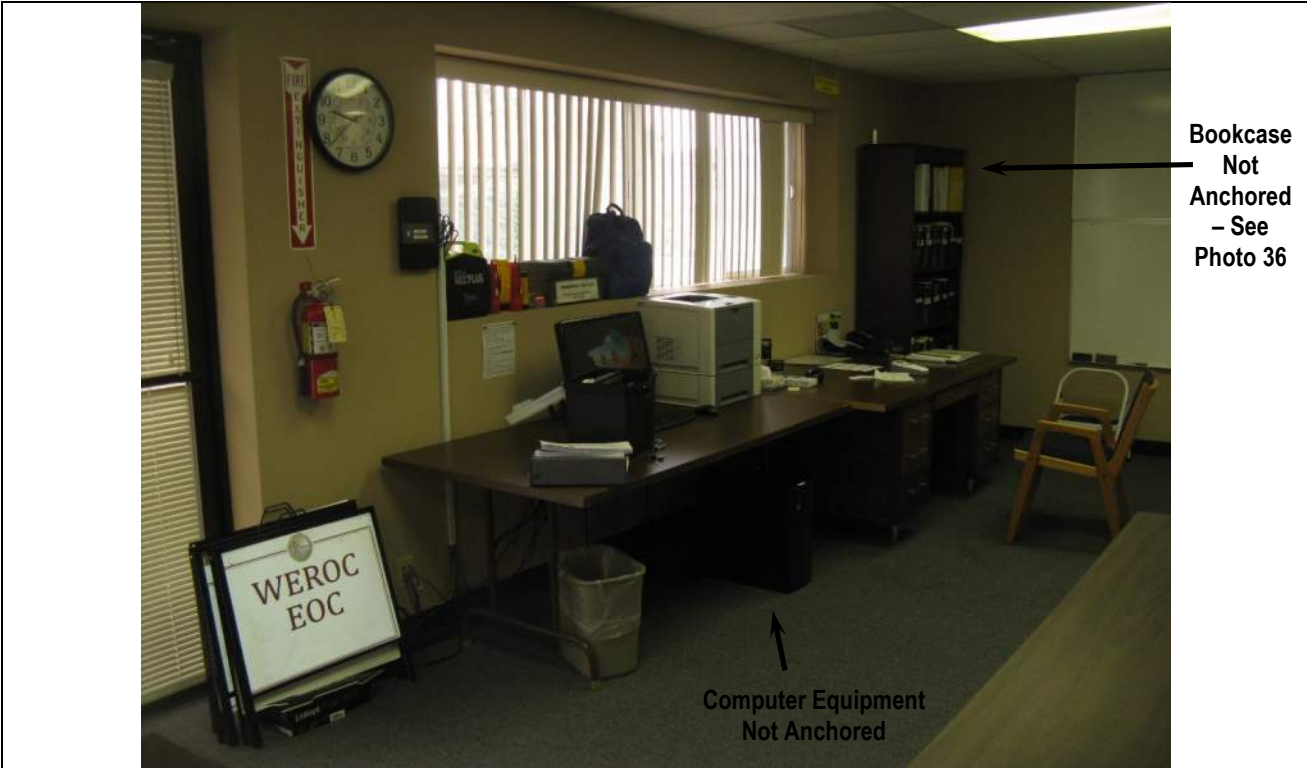
Photo 35: View at Office Area

- Contents Not Anchored – A tall and narrow book case was observed to not be anchored although restraint angles were present at its top [Photos 35 and 36]. Several maps in the EOC room were observed to have support clips without sufficient seismic restraint [Photo 37].

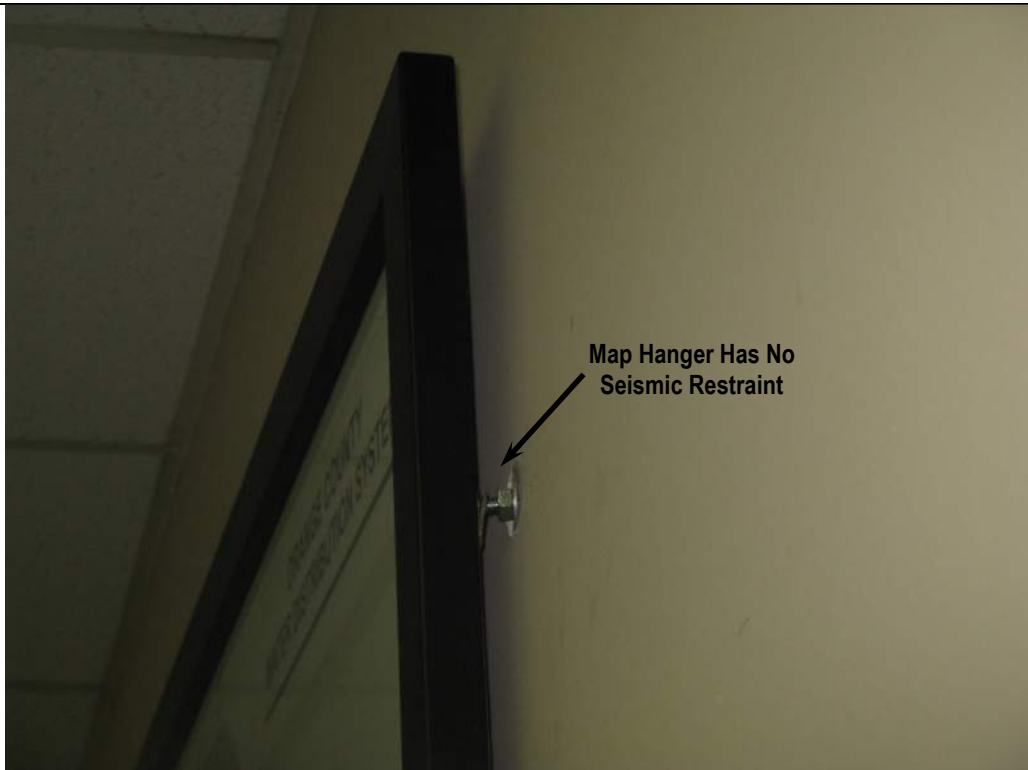
**Photo 37: Map Support Hanger in EOC**

Map Hanger Has No  
Seismic Restraint

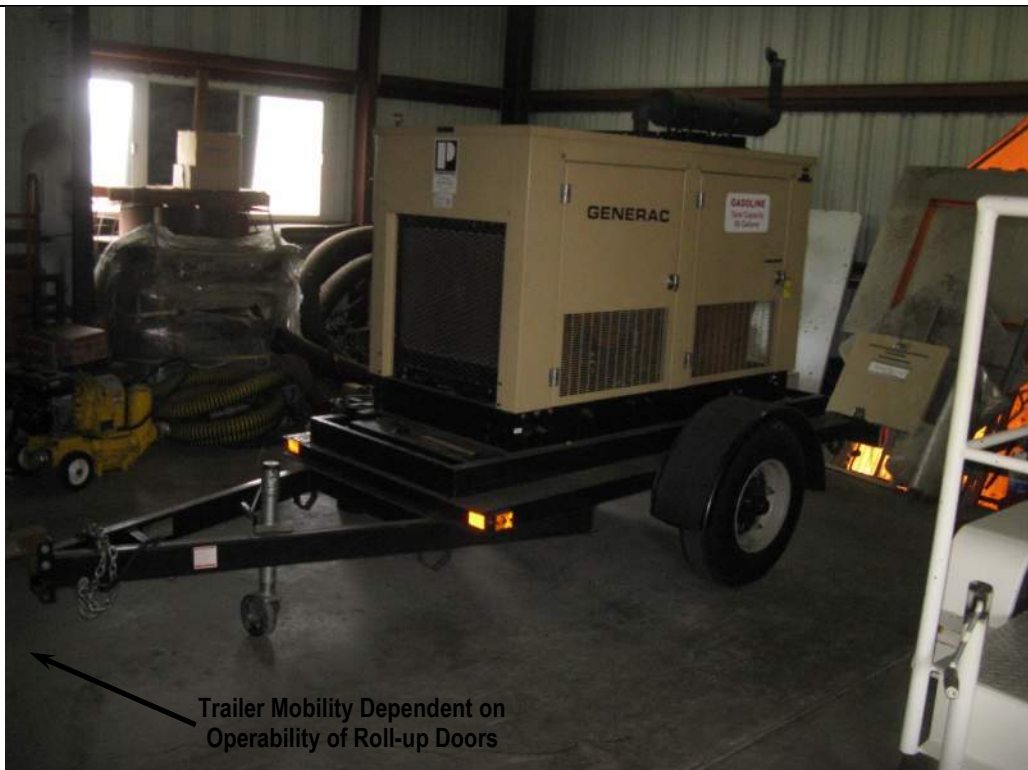
**Photo 38: Emergency Generator Trailer in Garage**

- Emergency Power Dependent on Roll-up Door Function – Since the trailer mounted emergency generator is located within the garage at the south end of the building, its use and operation depend on the functionality of the roll up doors. If building movements bind or otherwise disable the roll-up doors, use of the emergency generator may be impaired.

Trailer Mobility Dependent on  
Operability of Roll-up Doors
