**Report on the
Conceptual Seismic Retrofit Study
of the
MWDOC Administrative Building
18700 Ward Street, Fountain Valley, California**

IDS Project Number 17S020.01

February 26, 2018
(2/26/2018 update)

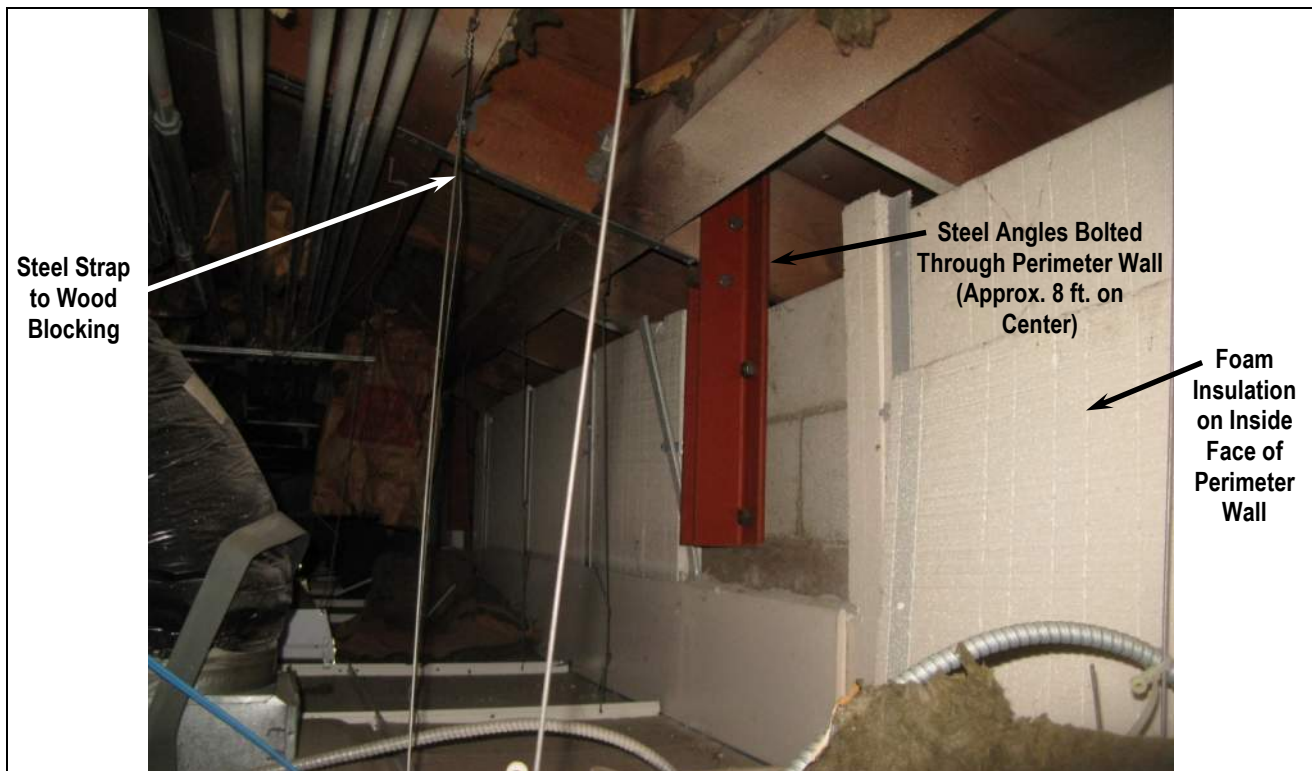
Photo 9: Typical Out of Plane Wall Anchorage Connection

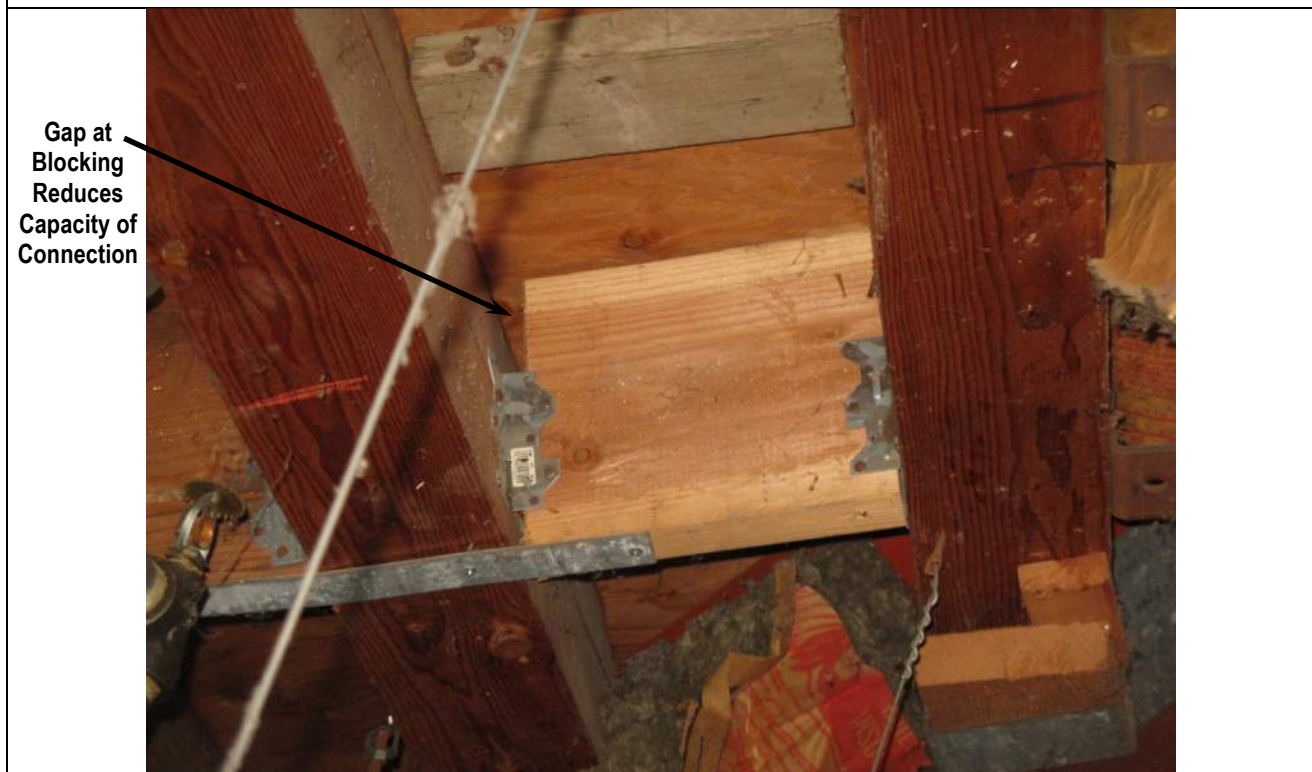
Photo 10: Close-up Showing Gap at Seismic Blocking

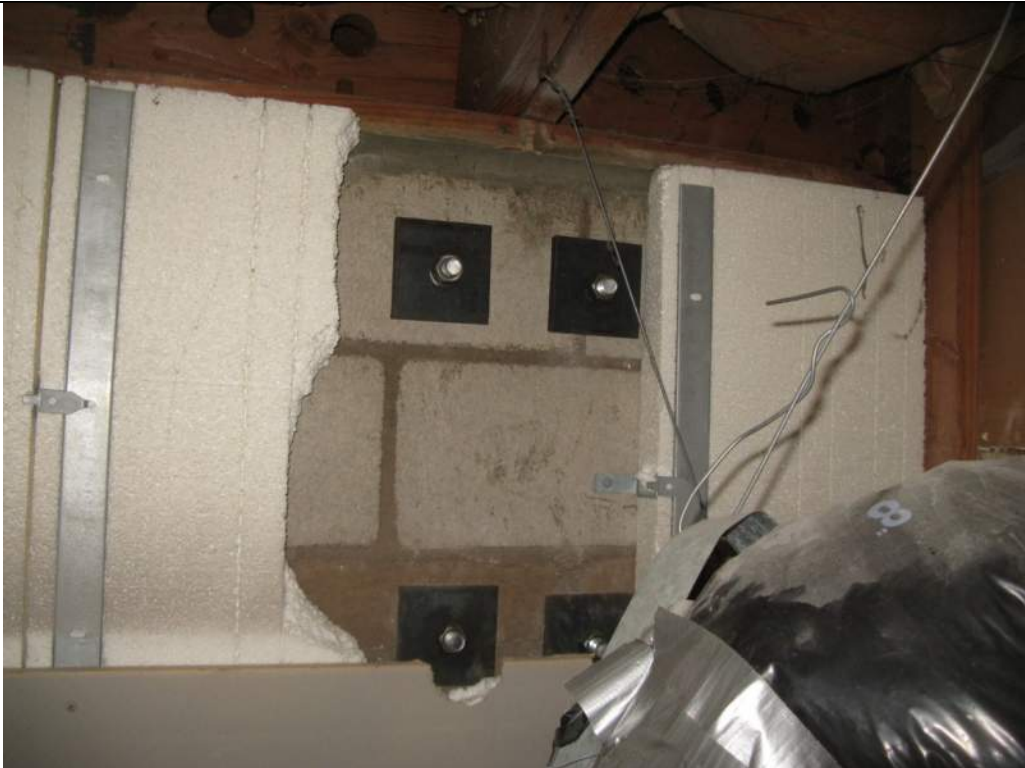
Photo 11: Wall Anchorage Connection Presumed to Exist on Far Side of Wall

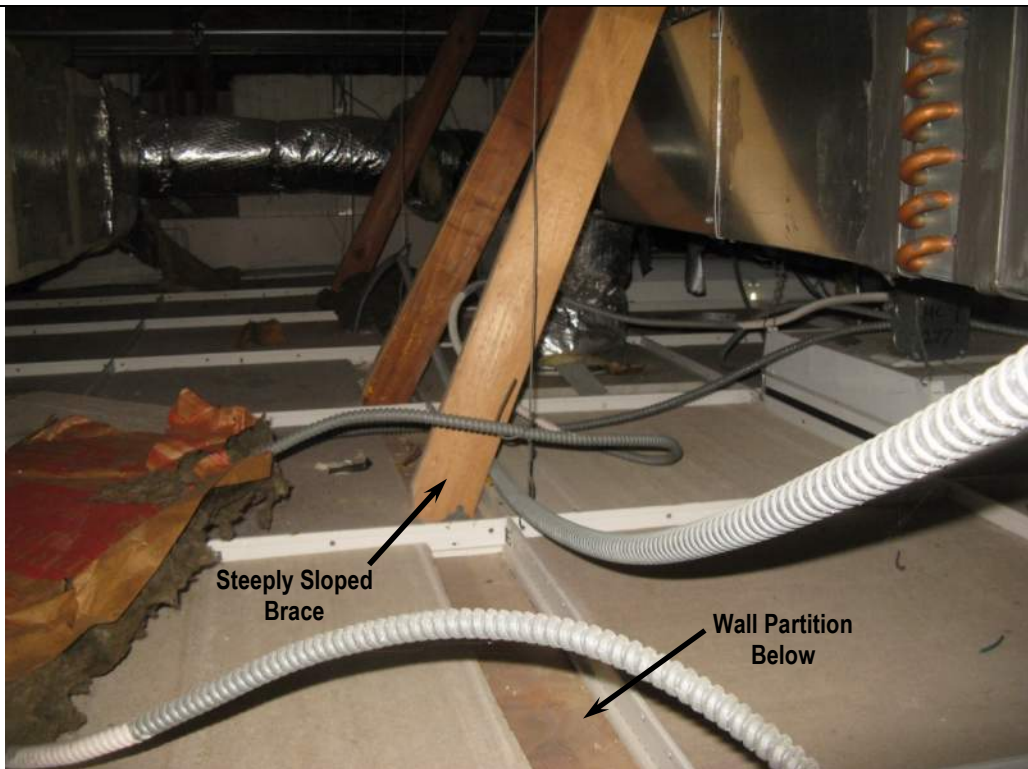
Photo 13: Steeply Sloped Partition Bracing

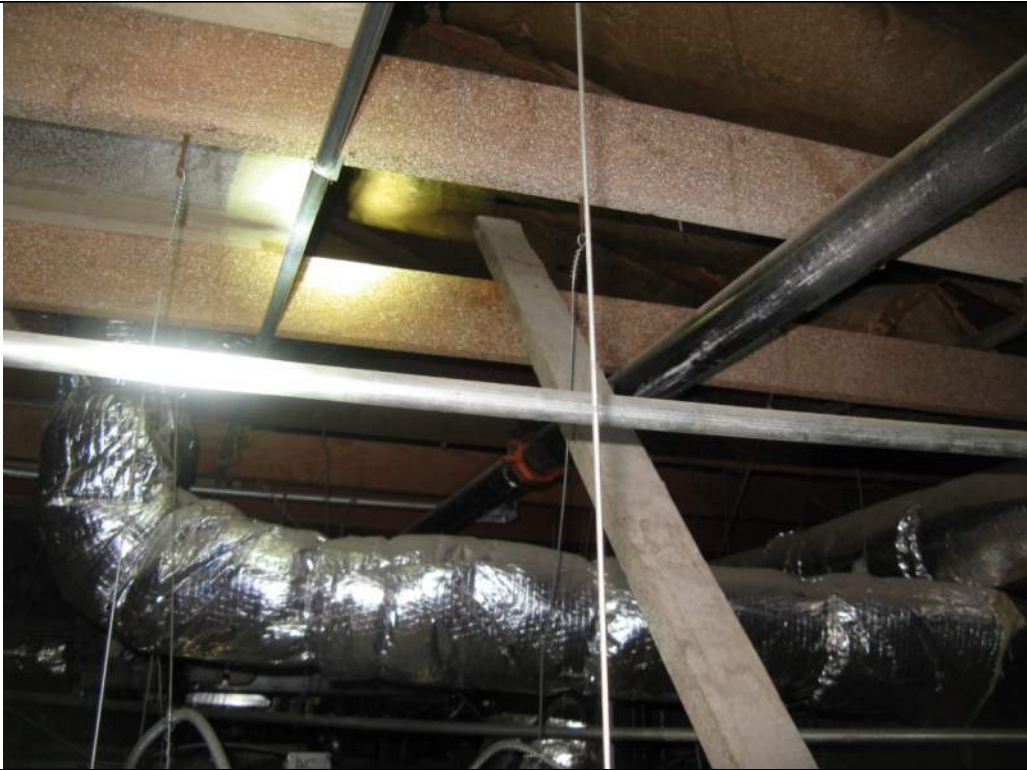
Photo 15: Partition Brace to Unbraced Roof Framing

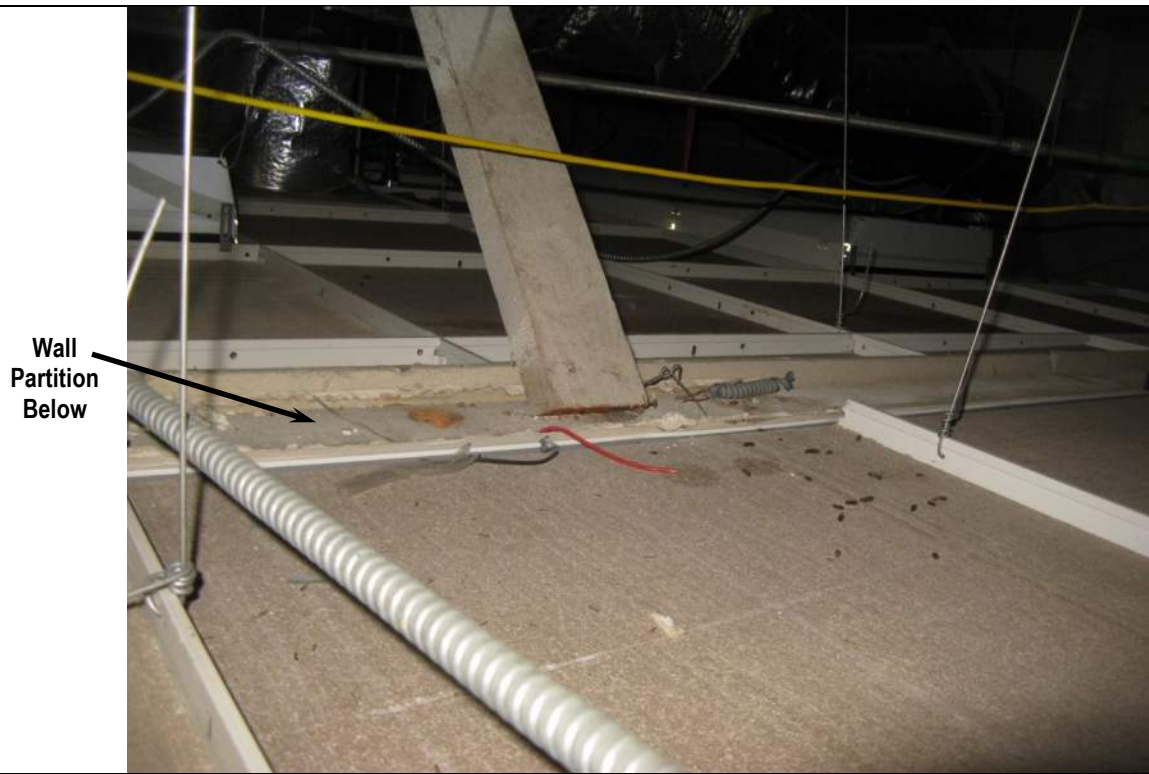
Photo 16: Widely Spaced, Steeply Sloped and Inadequate Brace Connection

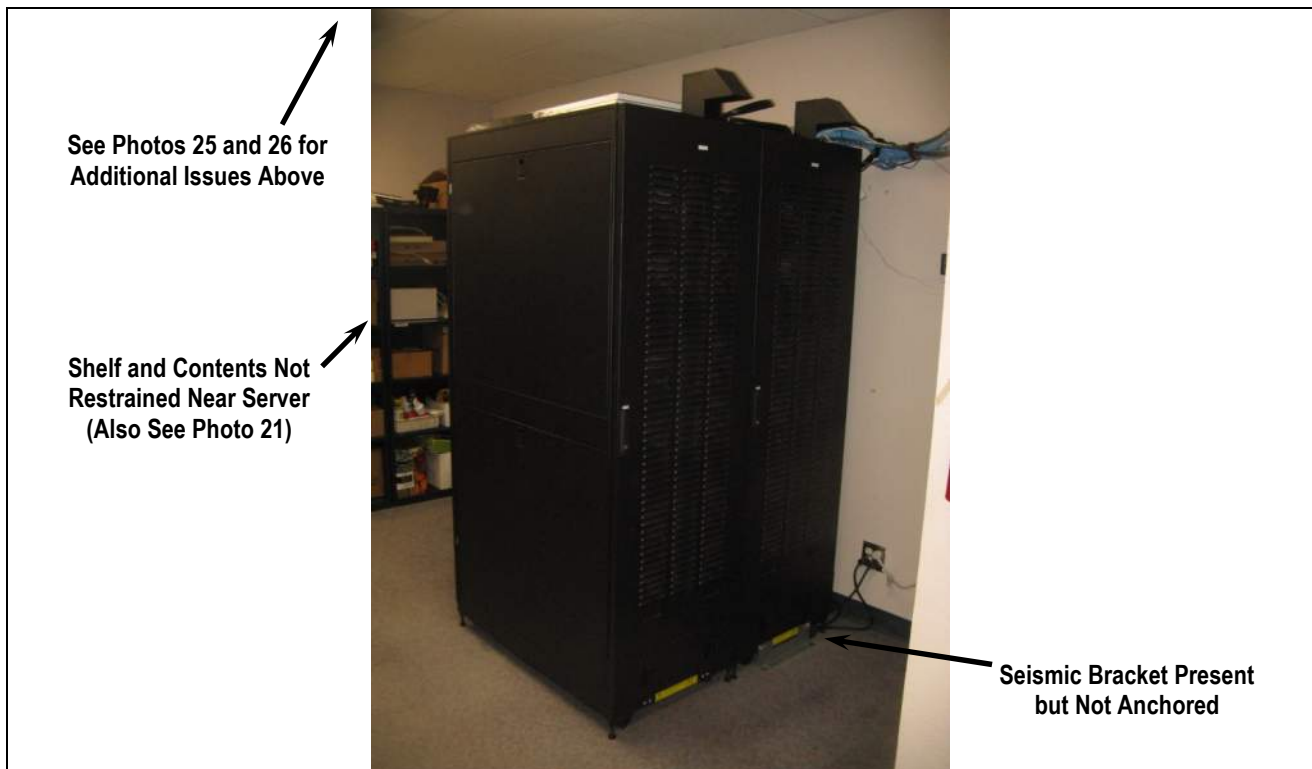
Photo 17: Computer Server Cabinet Not Anchored

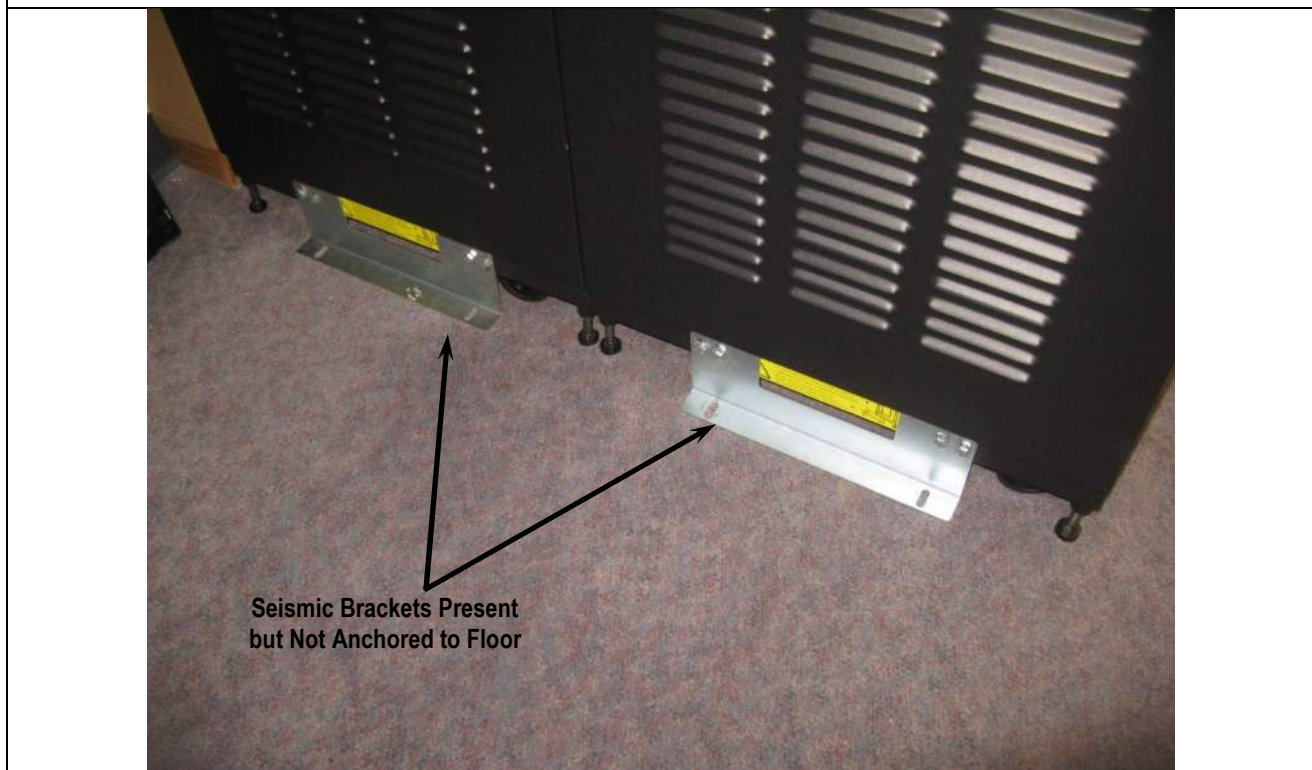
Photo 18: Computer Server Cabinet Not Anchored

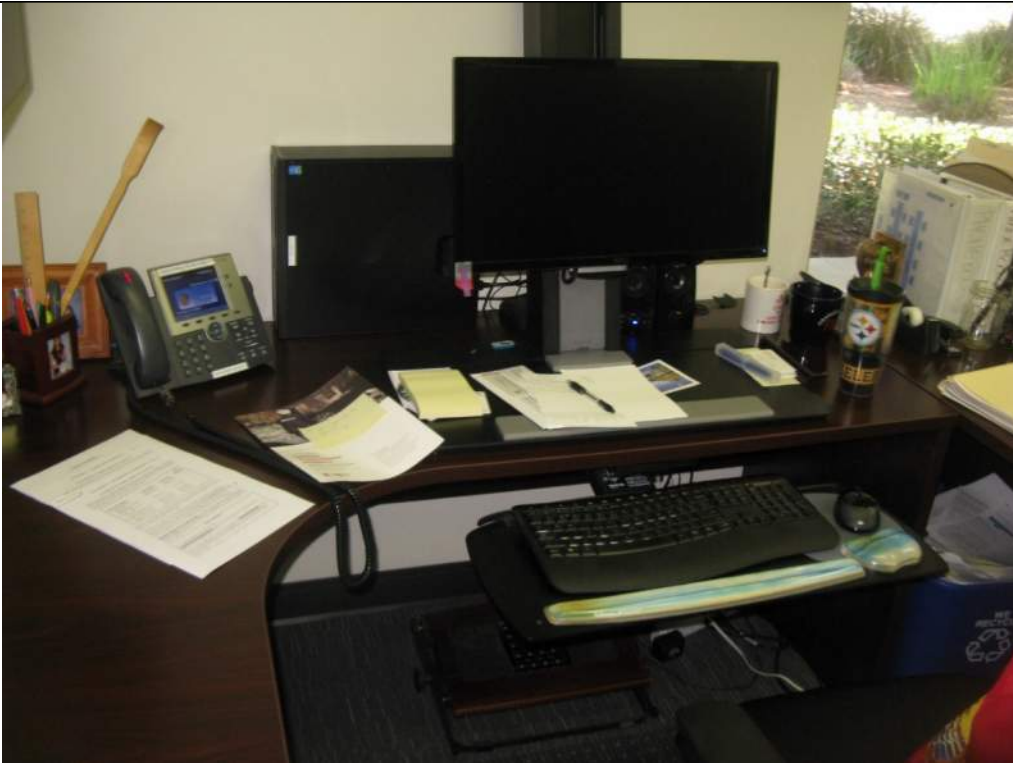
Photo 19: Typical Unanchored Office Computer Equipment

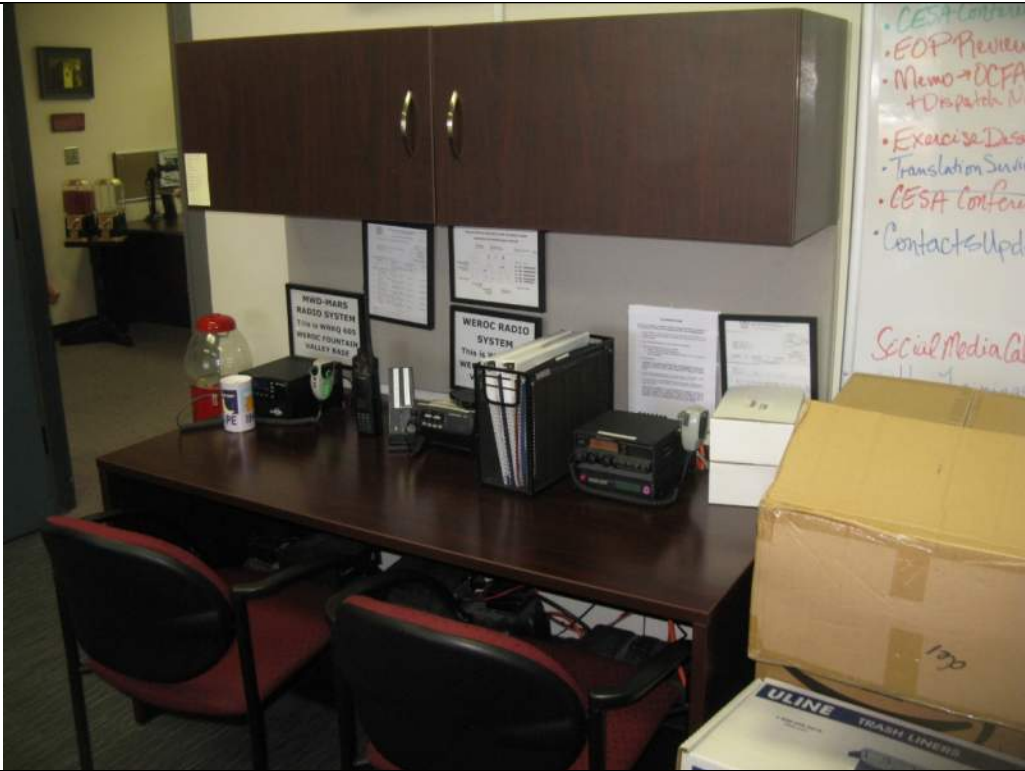
Photo 20: Unrestrained Communications Equipment

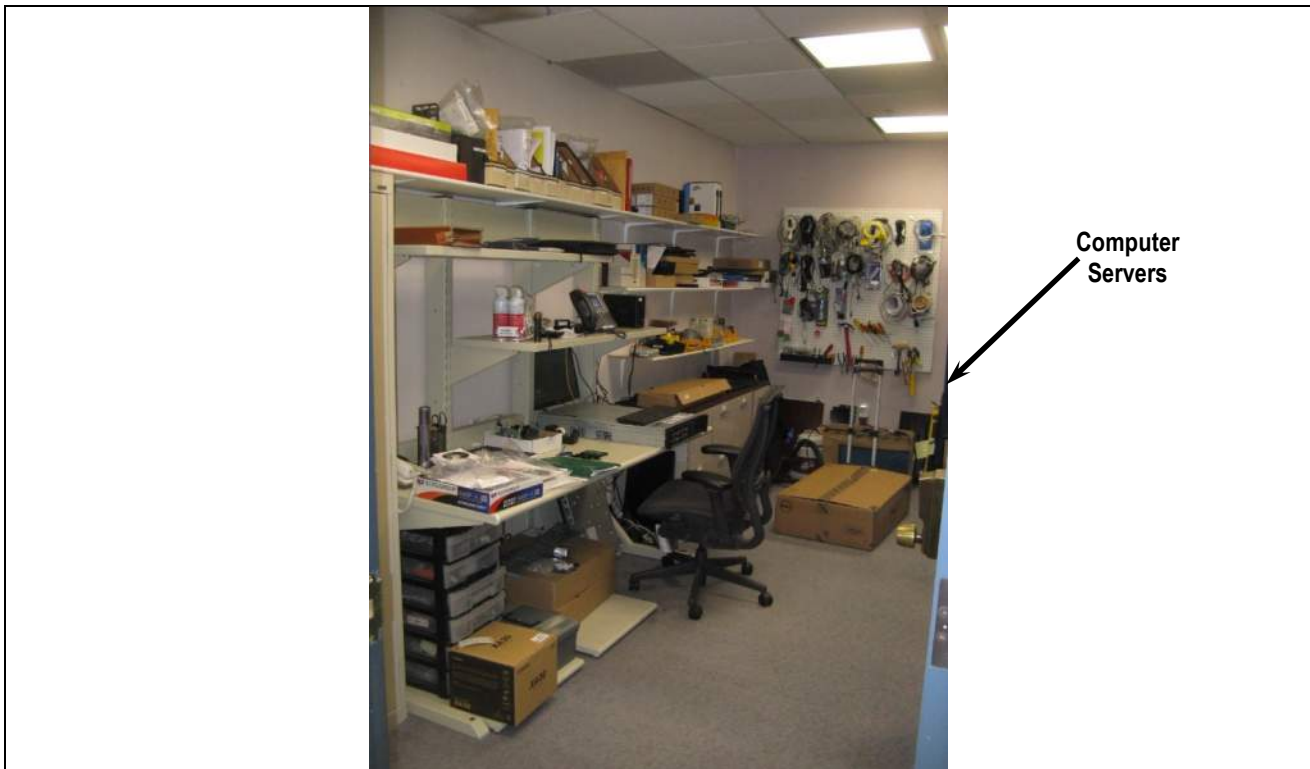
Photo 21: Unrestrained Contents in Computer Server Room

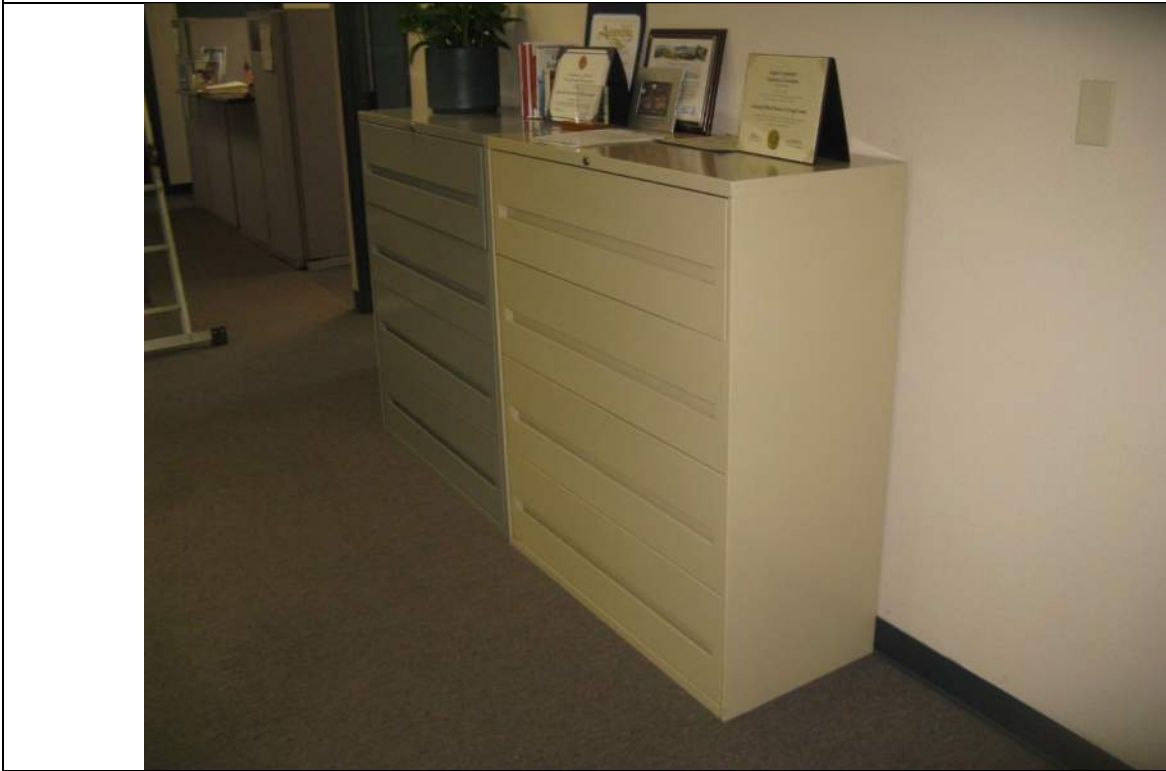
Photo 22: Unanchored Tall Narrow Contents in Hallway

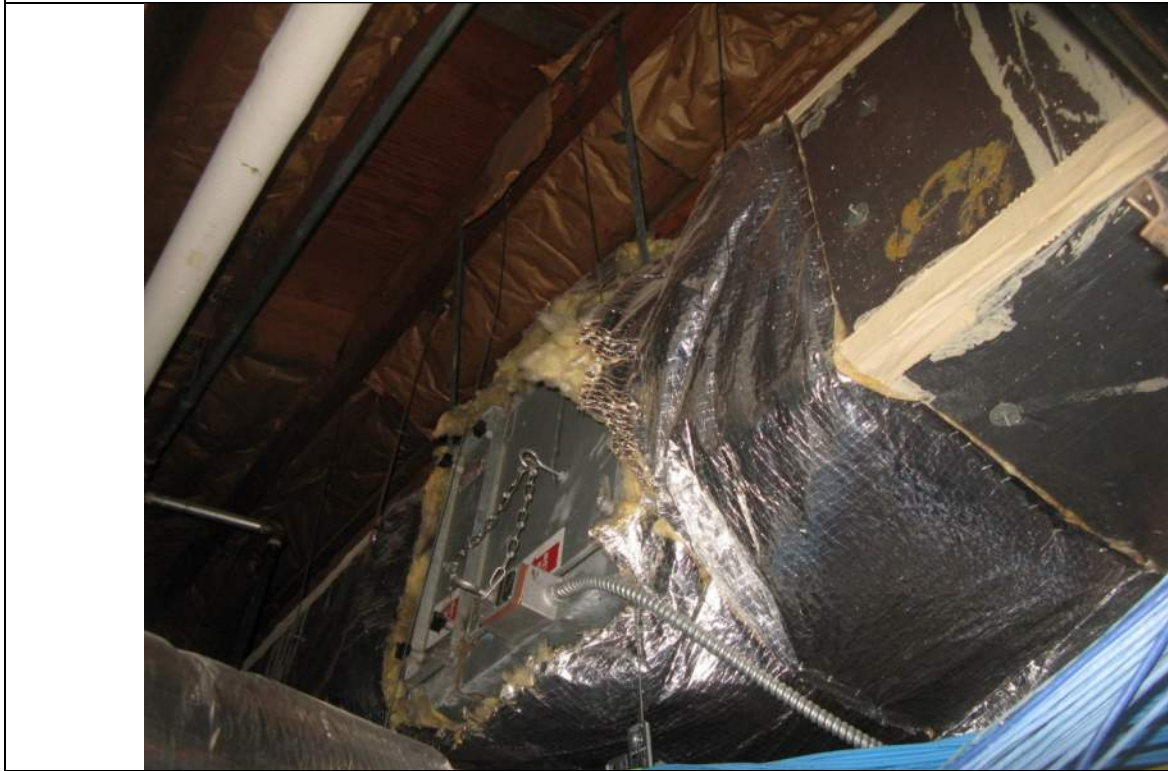
Photo 28: Typical In-Line Mechanical Unit without Seismic Bracing

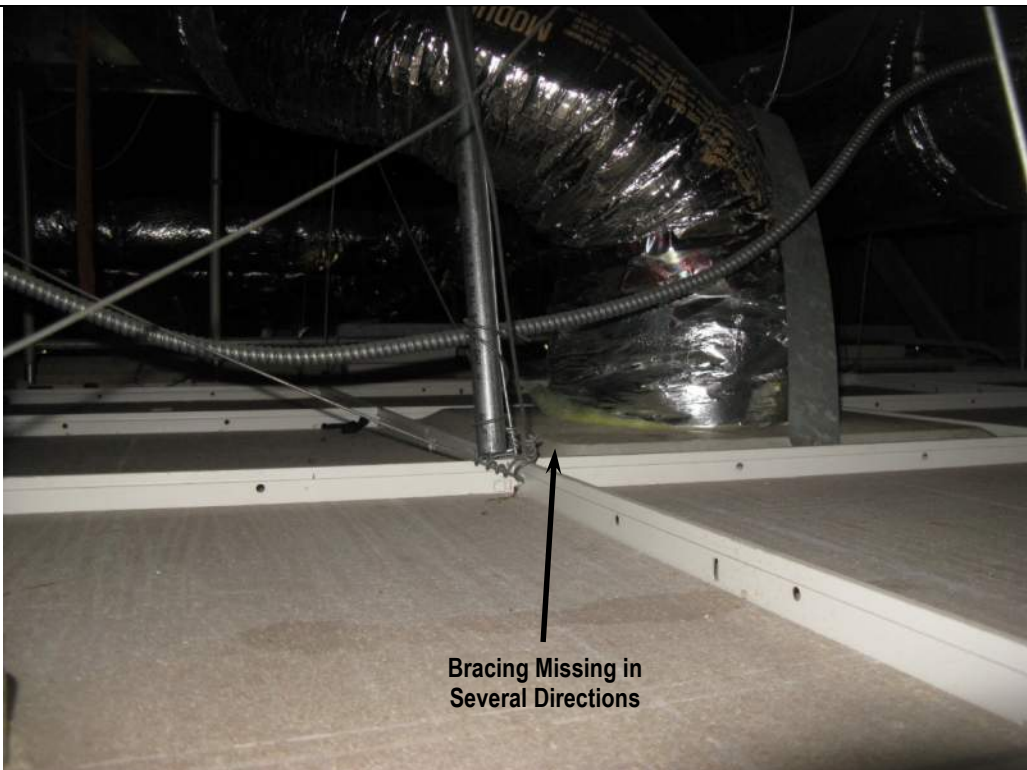
Bracing Missing in
Several Directions

Photo 30: View of Incomplete Lateral Bracing

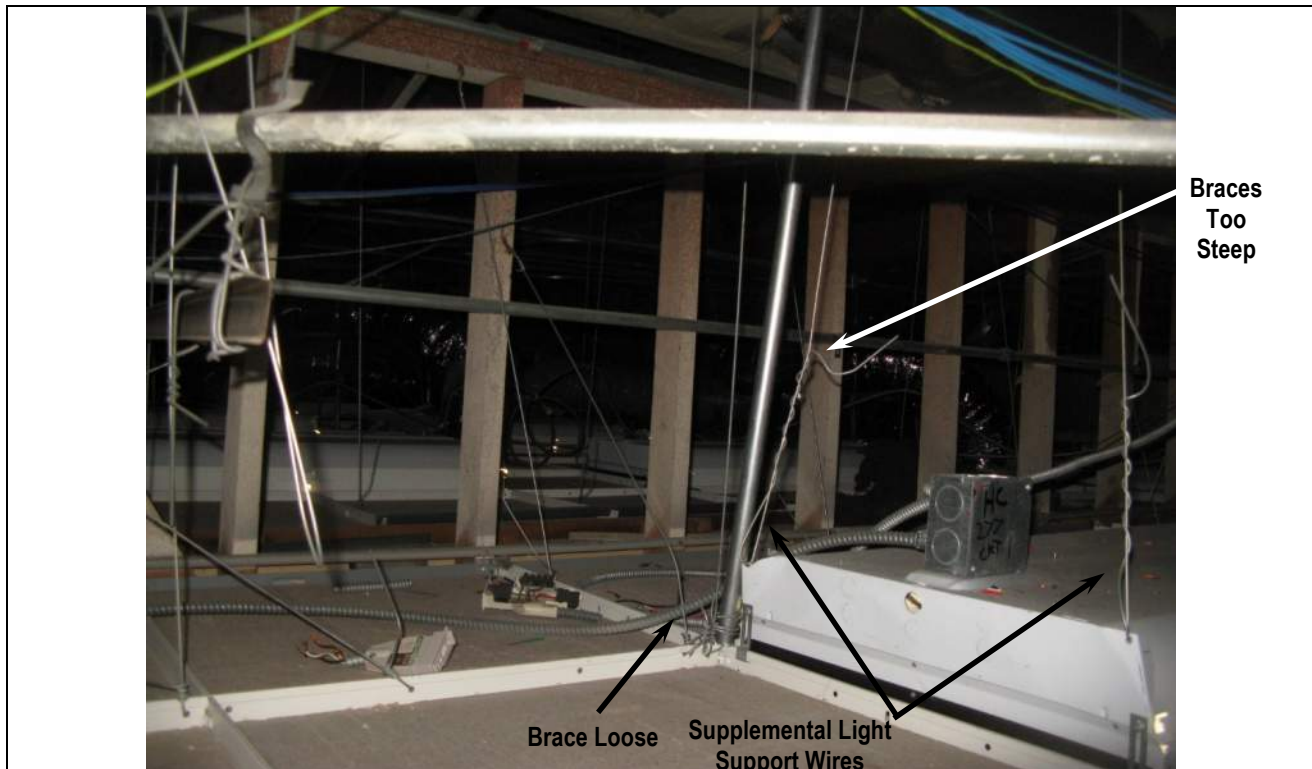
- Lights, Ceilings and Partitions – Support and bracing of lights, ceilings and partitions was found to be deficient.

Photo 31: Incomplete/ Improper Ceiling Bracing

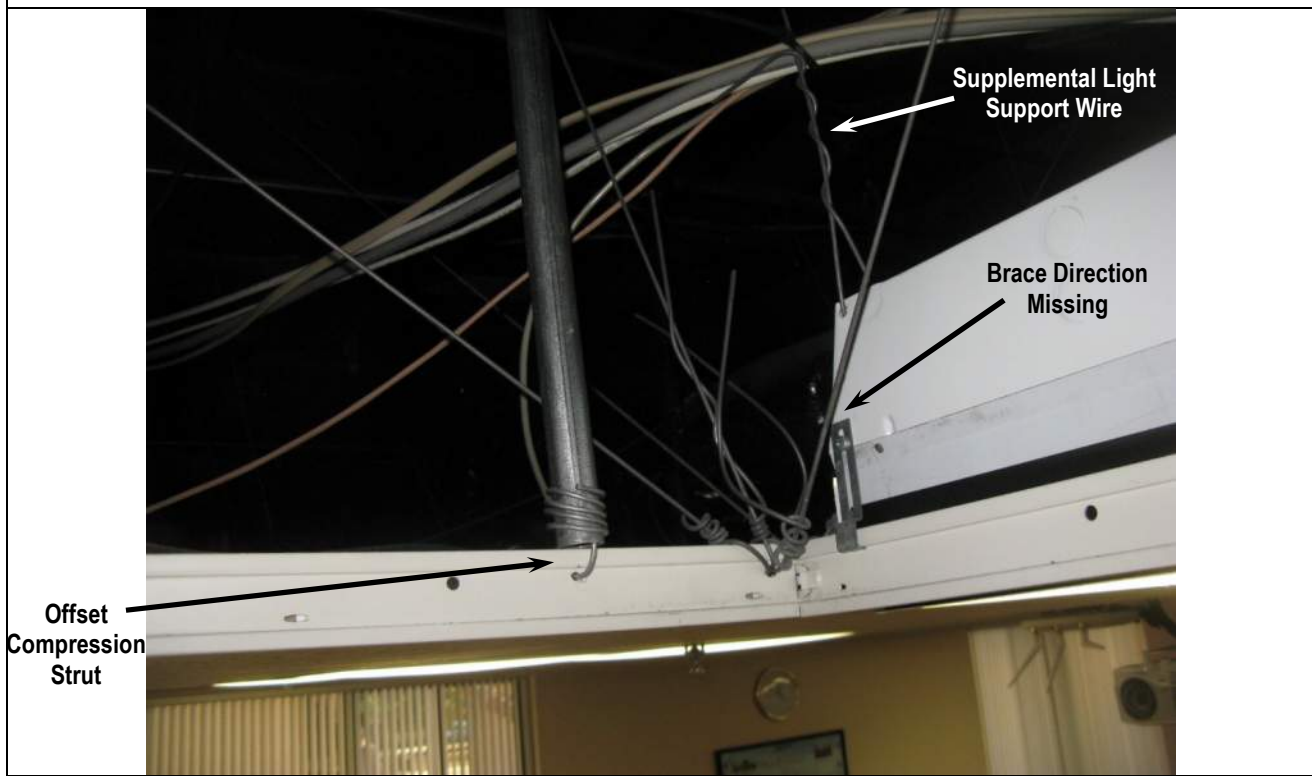
Photo 32: Improper Ceiling Bracing Above Front/Main Conference Room

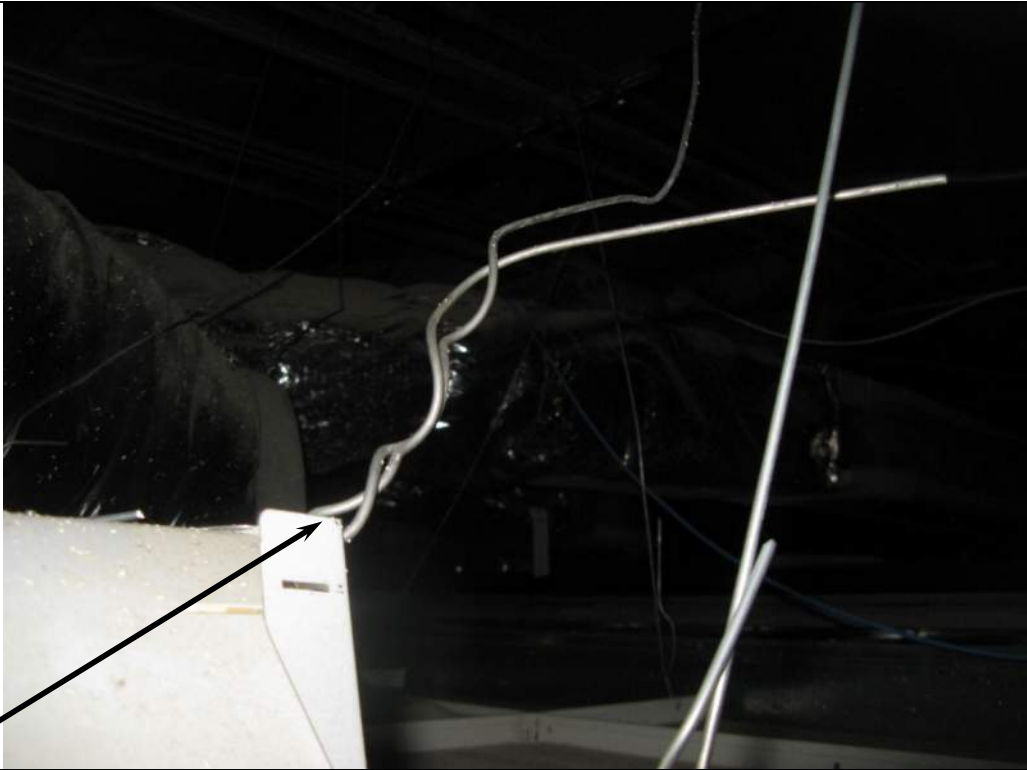
Photo 33: Improper Light Support Wire

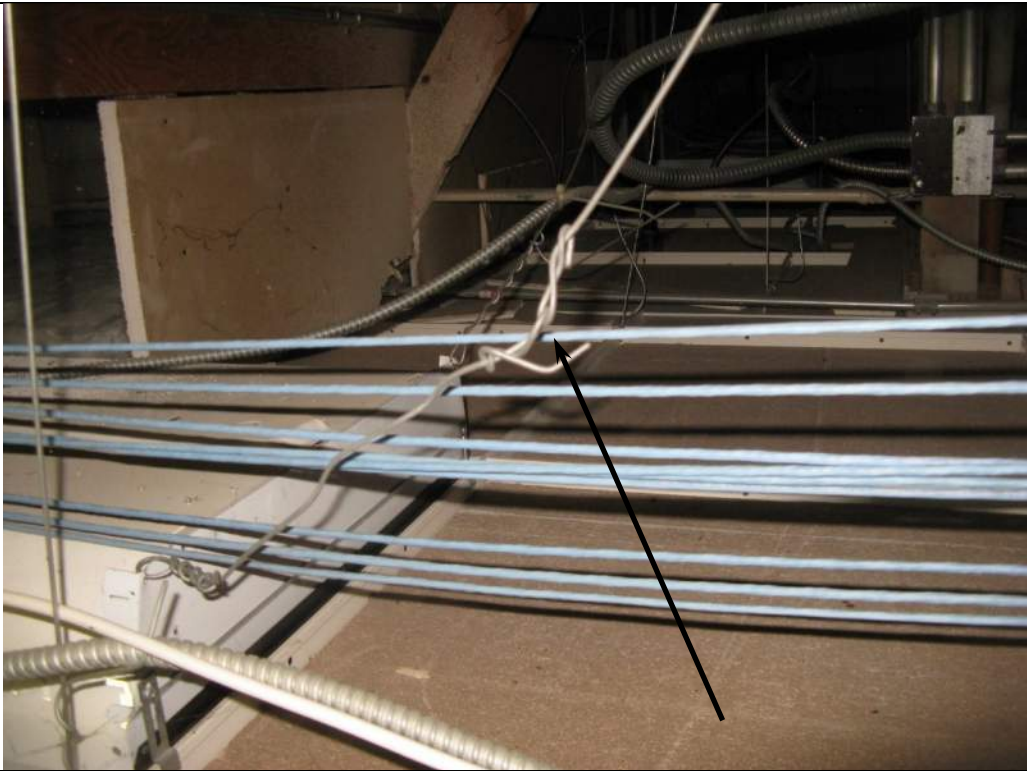
Photo 34: Improper Light Support Wire
