**Report on the
Conceptual Seismic Retrofit Study
of the
MWDOC Administrative Building
18700 Ward Street, Fountain Valley, California**

IDS Project Number 17S020.01

February 26, 2018
(2/26/2018 update)

CONCEPTUAL SEISMIC RETROFIT STUDY MWD OC ADMINISTRATIVE BUILDING FOUNTAIN VALLEY, CA

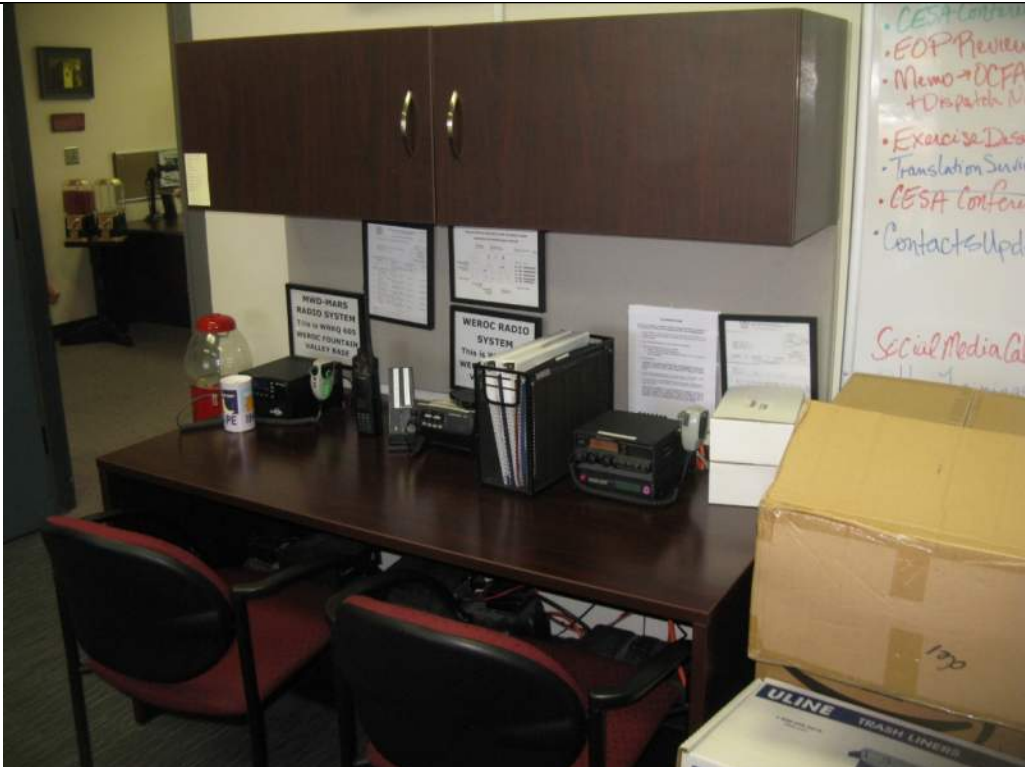
Photo 20: Unrestrained Communications Equipment

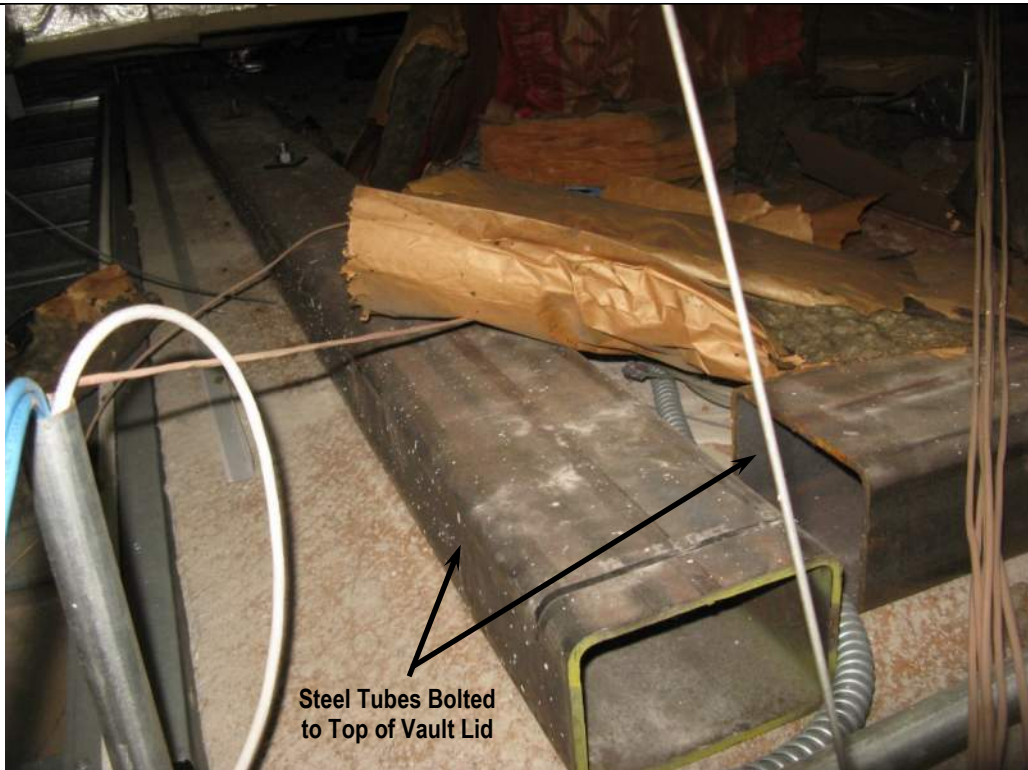
Photo 35: Reinforcement of Vault Lid
