June 28, 2017

Ms. Kelly Hubbard
Emergency Services Manager
WATER EMERGENCY RESPONSE ORGANIZATION OF ORANGE COUNTY
18700 Ward Street
Fountain Valley, CA 92708

**Subject: Seismic Assessment of the South Emergency Operations Center
26081 Via Pera, Mission Viejo, CA 92691**
IDS Job Number: 17S020

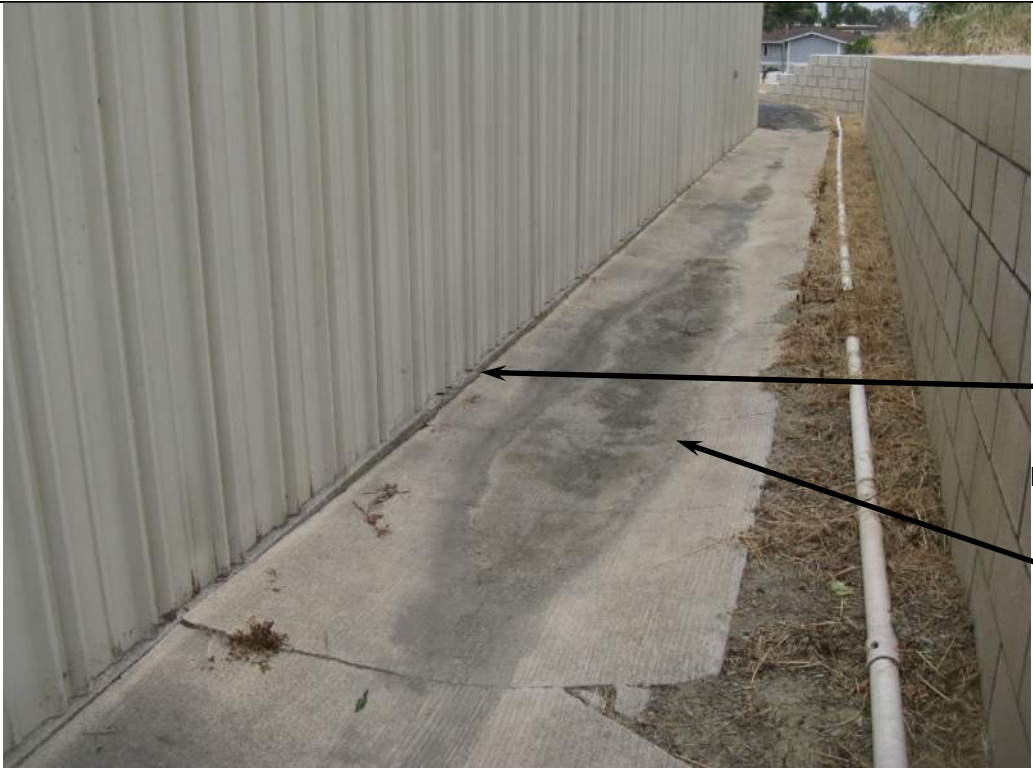
- Concrete Slab Damage – The majority of the concrete slab on grade was covered by carpeting or other floor finishes and so was not open to view. However, the slab in the garage area at the south end of the building was bare and open to view. In this area, we observed some linear cracking that did not appear unusual for slabs of this type with its existing joint spacing [Photo 15]. We also observed one location at the front of the garage where the concrete slab has cracked between the door jamb anchors and the slab edge [Photo 12]. A small area (approximately 2 feet long) of deterioration of an exposed slab edge on the west side of the building was also observed. The corner of the concrete in this area appears to

have eroded away, however the exposed aggregate appeared to be firmly embedded and the concrete paste appeared sound [Photo 11].

Localized
Concrete
Surface
Deterioration
at Slab Edge

Evidence of
Ponding in
Swale

Photo 11: View Along West Side of Building

5. Repair Damaged or Deteriorated Building Elements – Where damage or deterioration exists, we recommend repairing the elements to prevent or reduce future or ongoing damage and deterioration.

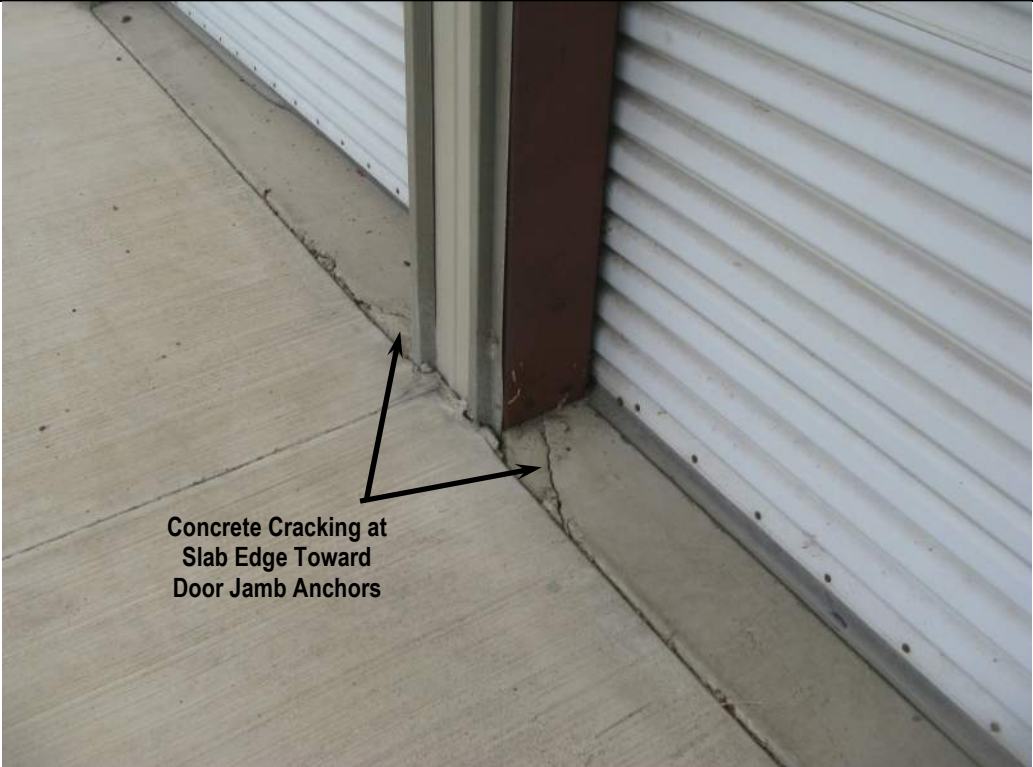
Concrete Cracking at
Slab Edge Toward
Door Jamb Anchors

Photo 12: Damaged Concrete at Slab Edge

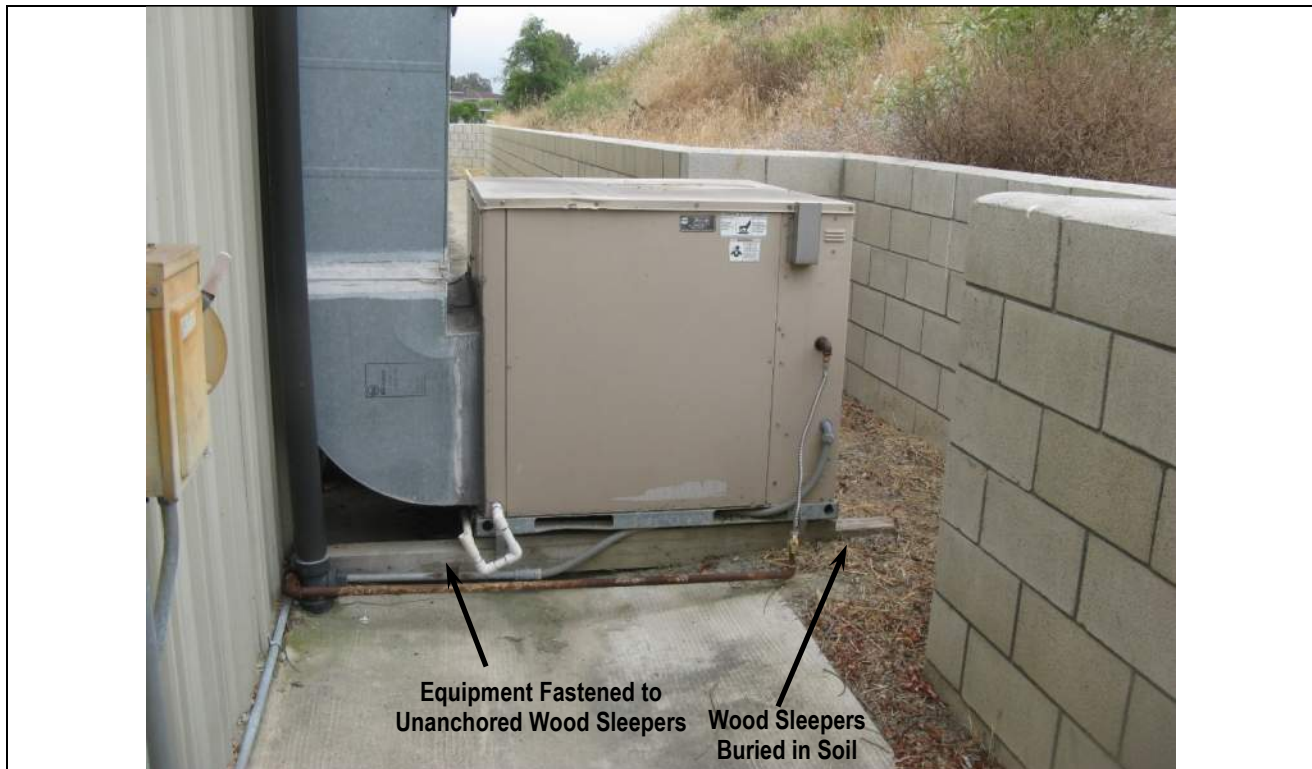
- Exterior Mechanical Equipment Not Anchored – A single mechanical unit exists on the west side of the building [Photos 13 and 14]. This unit is resting on two 4x4 sleepers, and has a flexible natural gas line, but is inadequately anchored for seismic forces.

Photo 13: Mechanical Equipment at West Side

4. Anchor Non-Structural Elements and Equipment – Anchorage and bracing of non-structural elements and equipment is necessary to prevent or reduce falling objects and potential damage to equipment necessary for emergency operations.

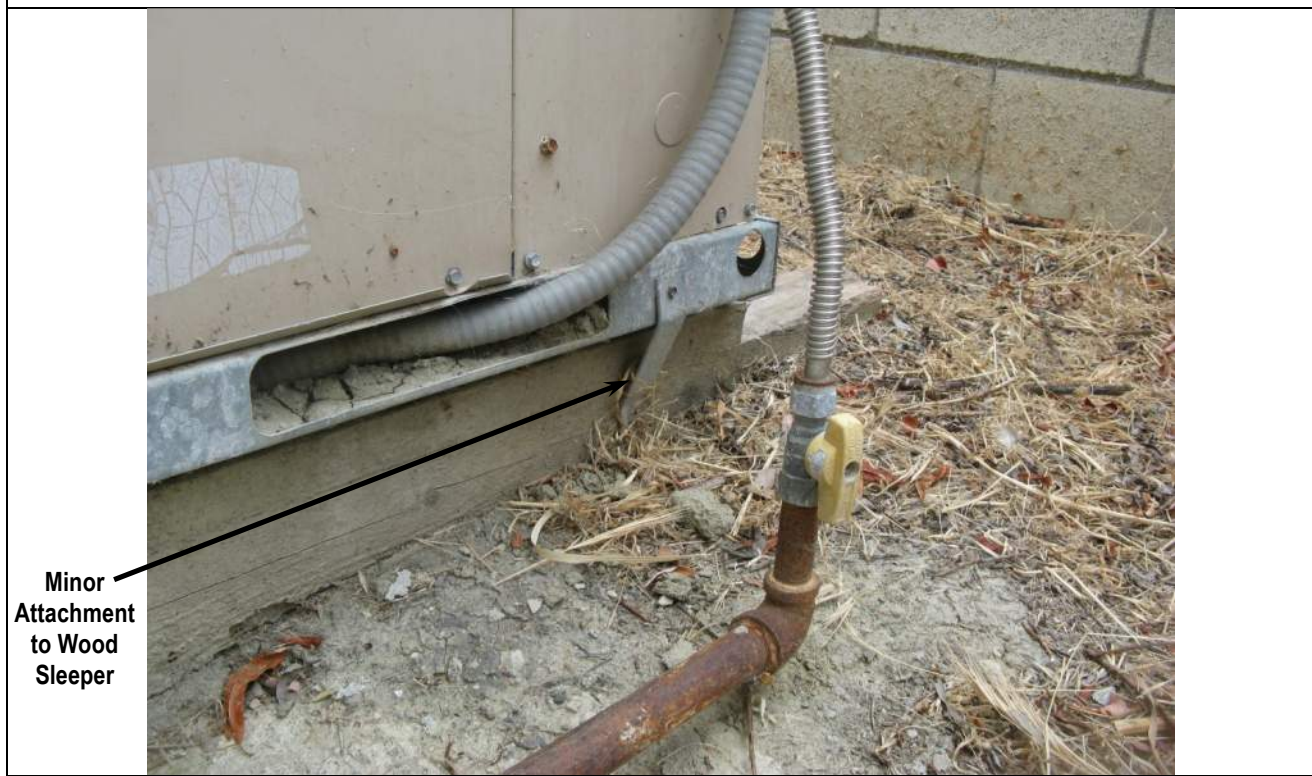
Photo 14: Close-up of Mechanical Equipment Attachment

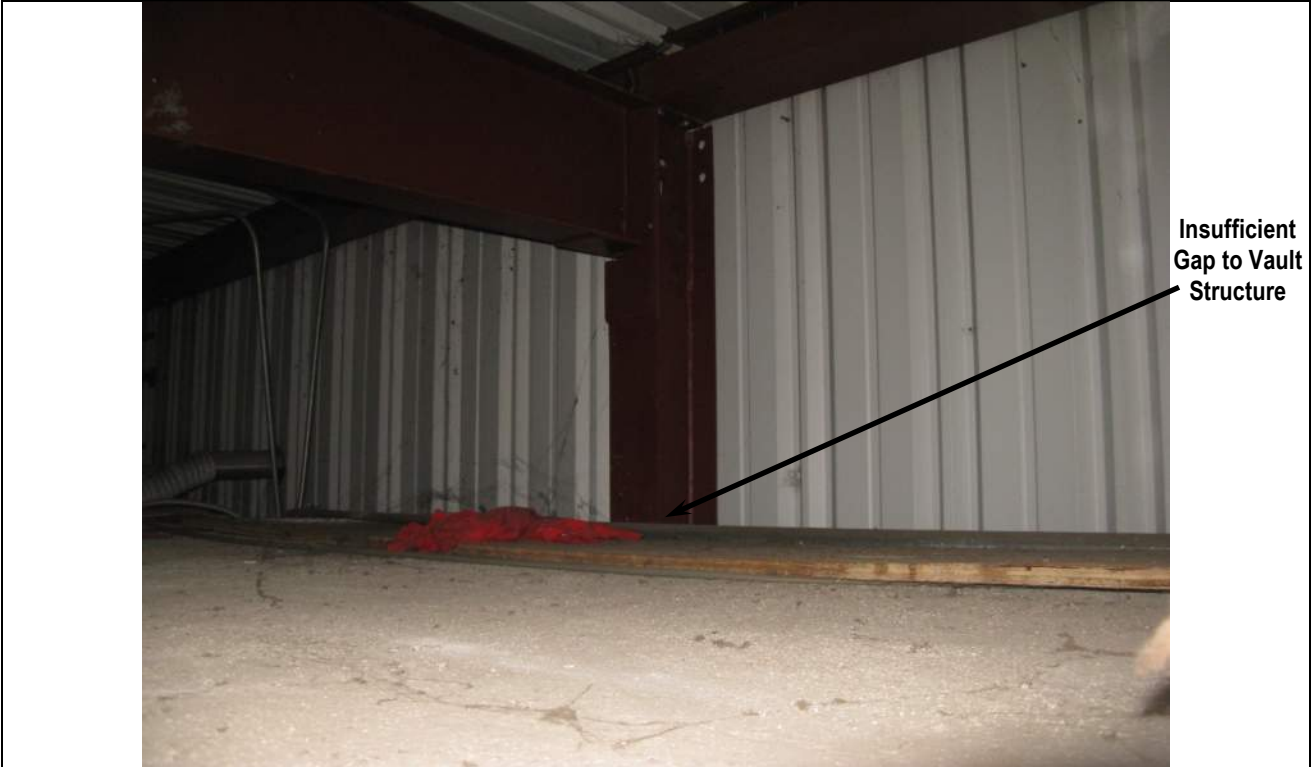
- Adjacent Structures– The concrete masonry vault structure inside the building is located adjacent to the first interior frame from the building's north end. There is insufficient gap between these two elements to prevent unintended interaction [Photo 18].

Photo 18: Rigid Frame Abutting Masonry Vault

3. Provide Seismic Separation at Masonry Vault – The masonry vault is a rigid element that will have almost no seismic movement relative to the surrounding building frame. Adequate separation of these elements is necessary to prevent damage to the building frame system.

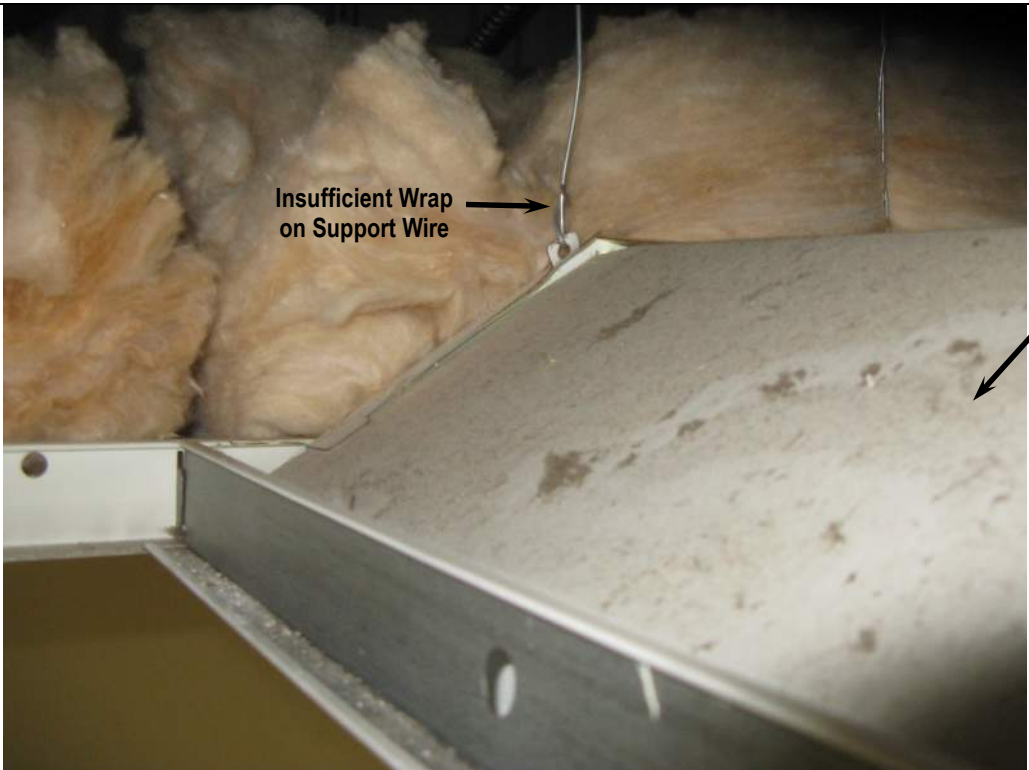
- Light Fixture Supplemental Support Wires Non-compliant – The light fixtures in the ceiling system were generally observed to have supplemental support wires at opposite corners of each fixture, but the wires were undersized (similar to the ceiling support wires) and were often improperly installed (also similar to the ceiling) [Photos 25 and 26].

Photo 25: View of Improper Light Support Wire

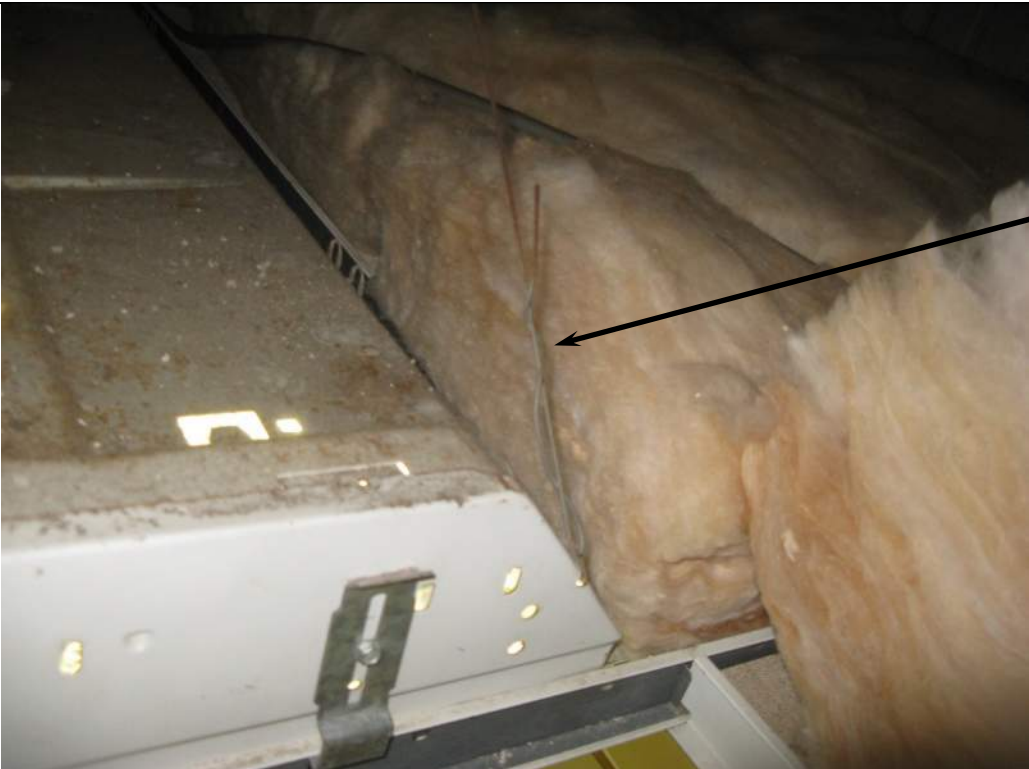
Photo 26: View of Improper Light Support Wire

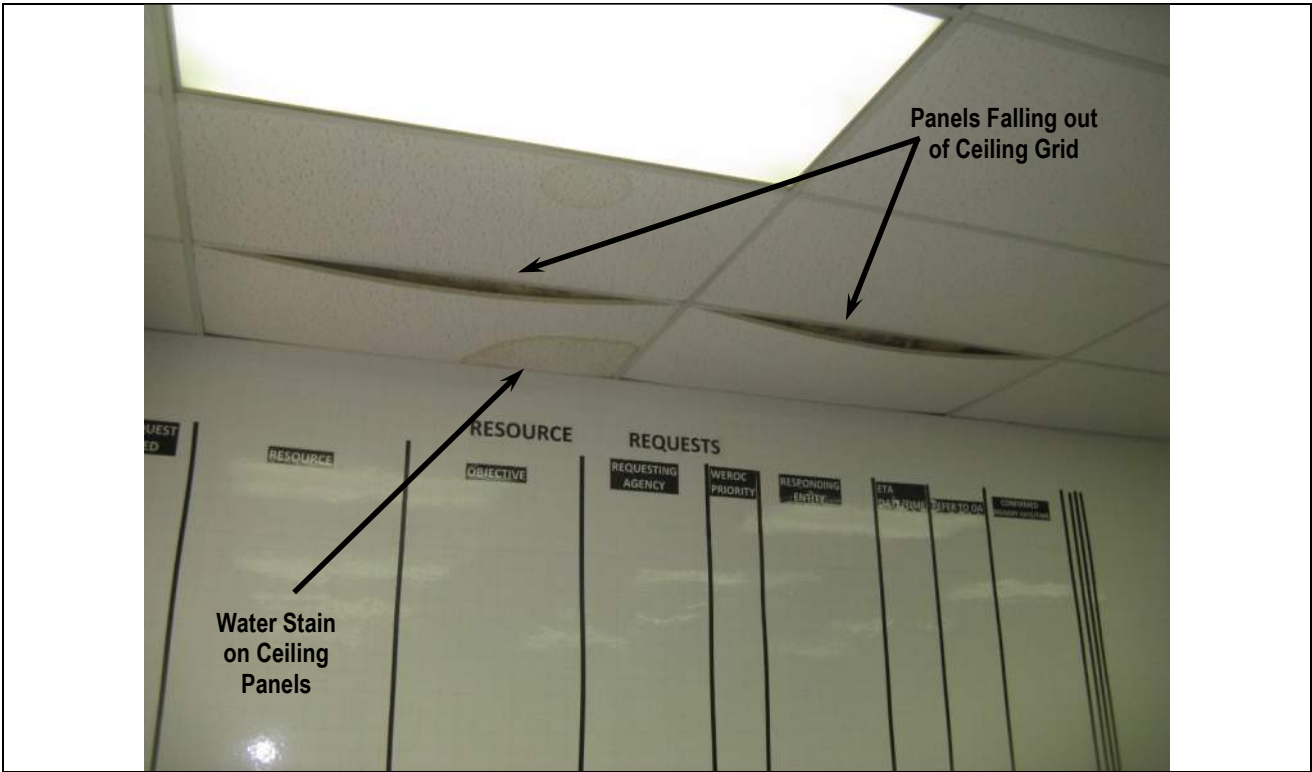
properly support the ceiling grid [Photos 19, 22 to 24]. The grid near the south exterior door to the EOC room was also observed to have several panels that were loose close to falling from the grid [Photo 27].

Photo 27: Damage and Falling Panels Near Entrance/Exit

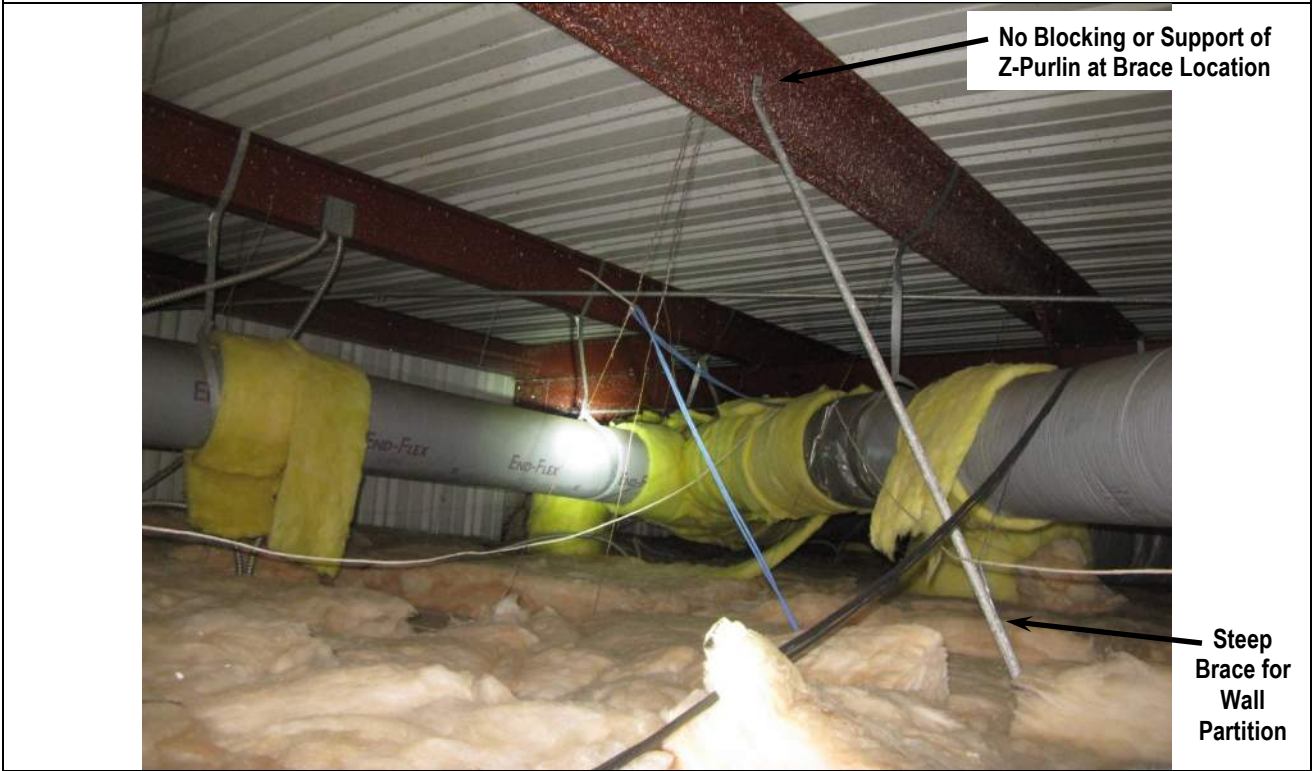
Photo 28: Typical View within Ceiling Space

- Interior Partition Bracing – Interior partitions were observed to have steep bracing to z-purlin members at locations without blocking or stability bracing. [Photos 28 and 29]. Along the perimeter of the building, the partitions appeared to be anchored and braced at their mid-height to the exterior wall wind girt members [Photo 30]. These partitions did not appear to have bracing at their top.

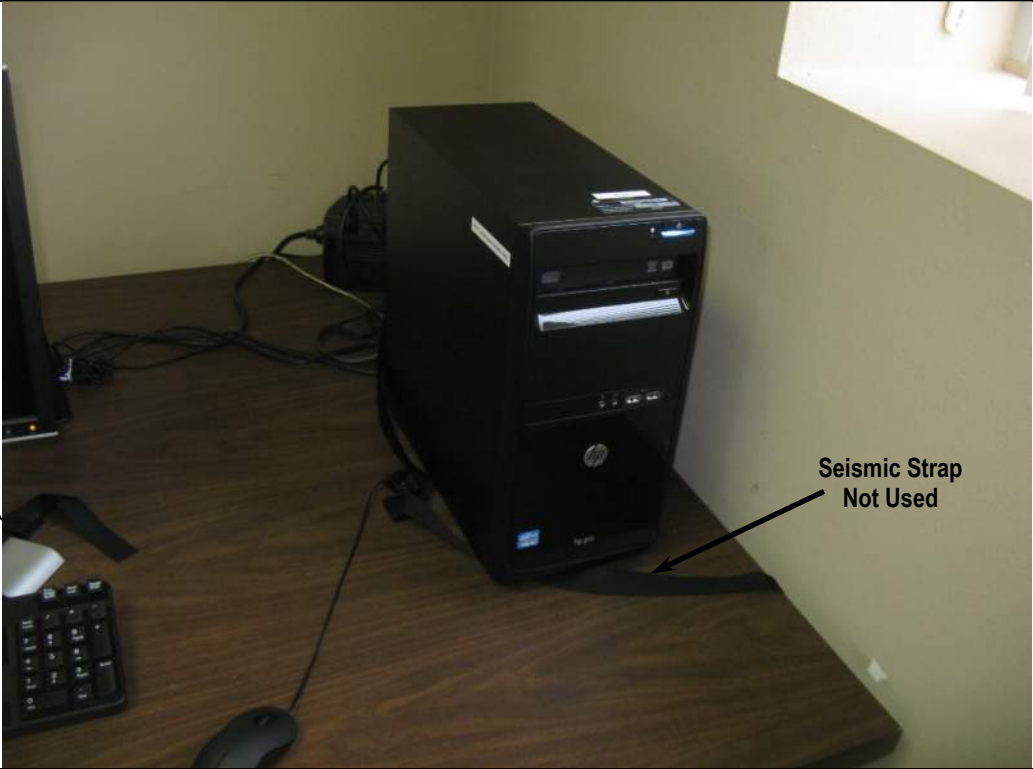
- Computer Equipment Not Anchored – Computer equipment presumed critical to the emergency operations was generally observed to have no seismic restraint or seismic straps and anchors that were not engaged [Photo 30]. Other equipment was also found to have no anchors or straps [Photos 31 to 35].

Photo 32: Unanchored Computer Equipment
