Hazardous Building Materials Inspection Report

Municipal Water District of Orange County
Administration Building
18700 Ward Street
Fountain Valley, California 92708

Project No. 20060

June 15, 2020

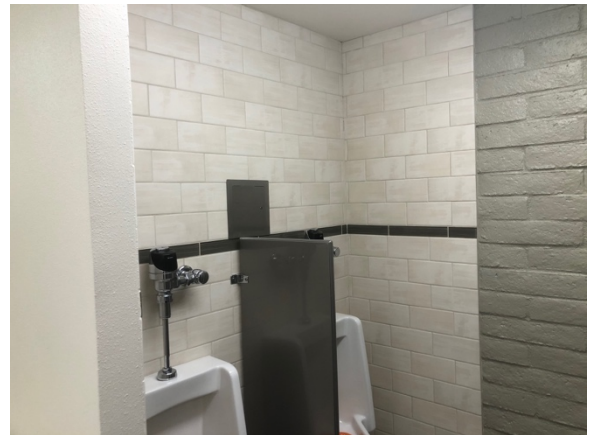
Restroom Wall Tile

Component	Results	Comments
Restroom Off White Ceramic Wall Tile	<40 mg/kg	Not glazed with lead

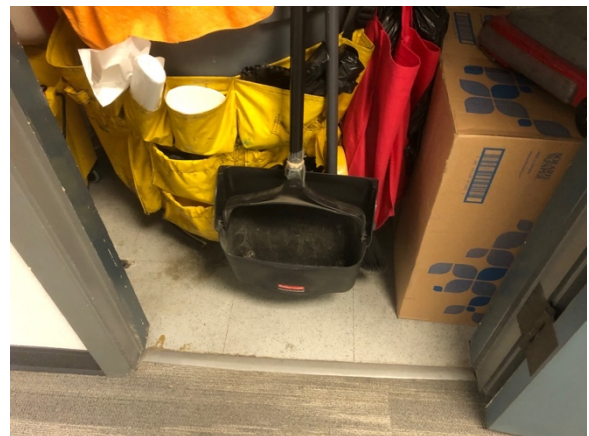
Tile (not ACM) in Janitorial Closet

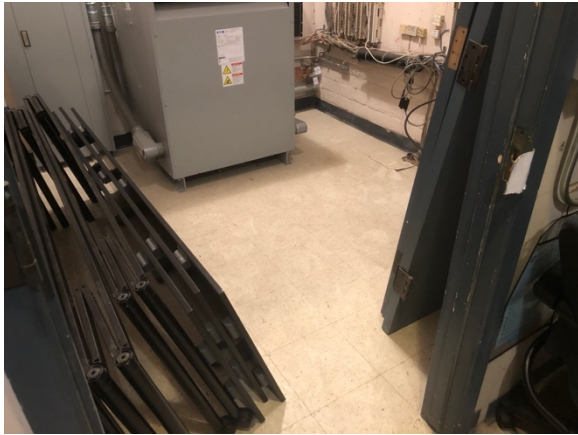
Tile and Mastic are ACM in the Electrical Room

Material Description	Material Location	Friability	Condition	Est. Qty.
Drywall Joint Compound	Walls and Hard Lid Ceilings	Non-Friable	Good	35,000 SF
Beige 12" Vinyl Floor Tile	Electrical Room	Non-Friable	Good	100 SF
Black Floor Tile Mastic	Electrical Room	Non-Friable	Good	100 SF

There are asbestos-containing materials at this property that will be impacted by the renovations. The identified asbestos-containing materials must be removed by a licensed and certified asbestos abatement contractor prior to the planned renovation work pursuant to Rule 1403 of the South Coast Air Quality Management District and Cal/OSHA Asbestos Regulations.

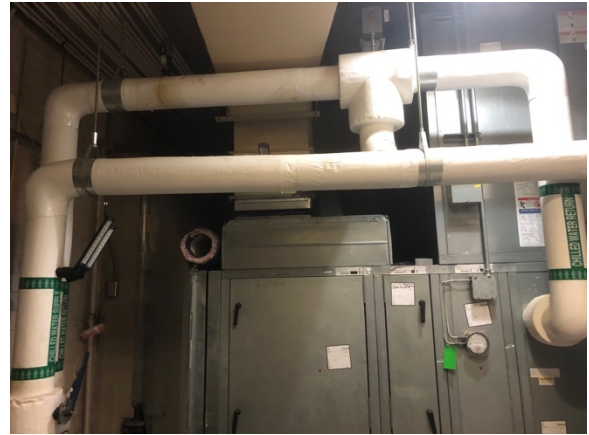
Typical Fiberglass Insulation

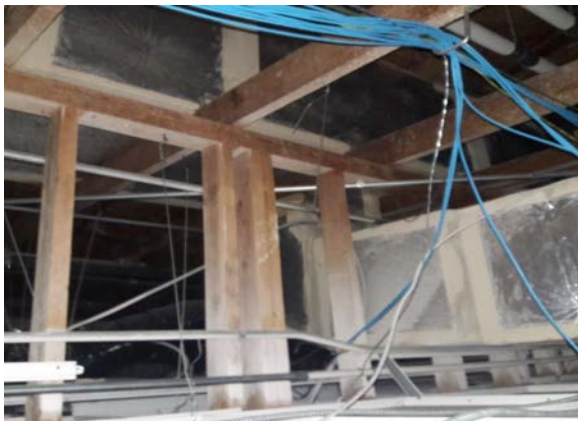
Ducts above the ceiling with foil backed insulation

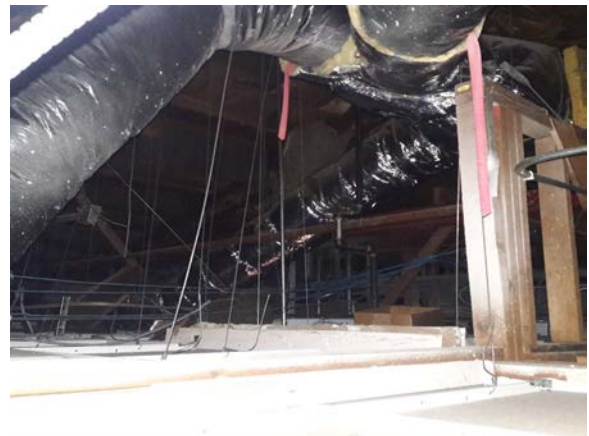
Above Ceiling, Fiberglass insulated ducts

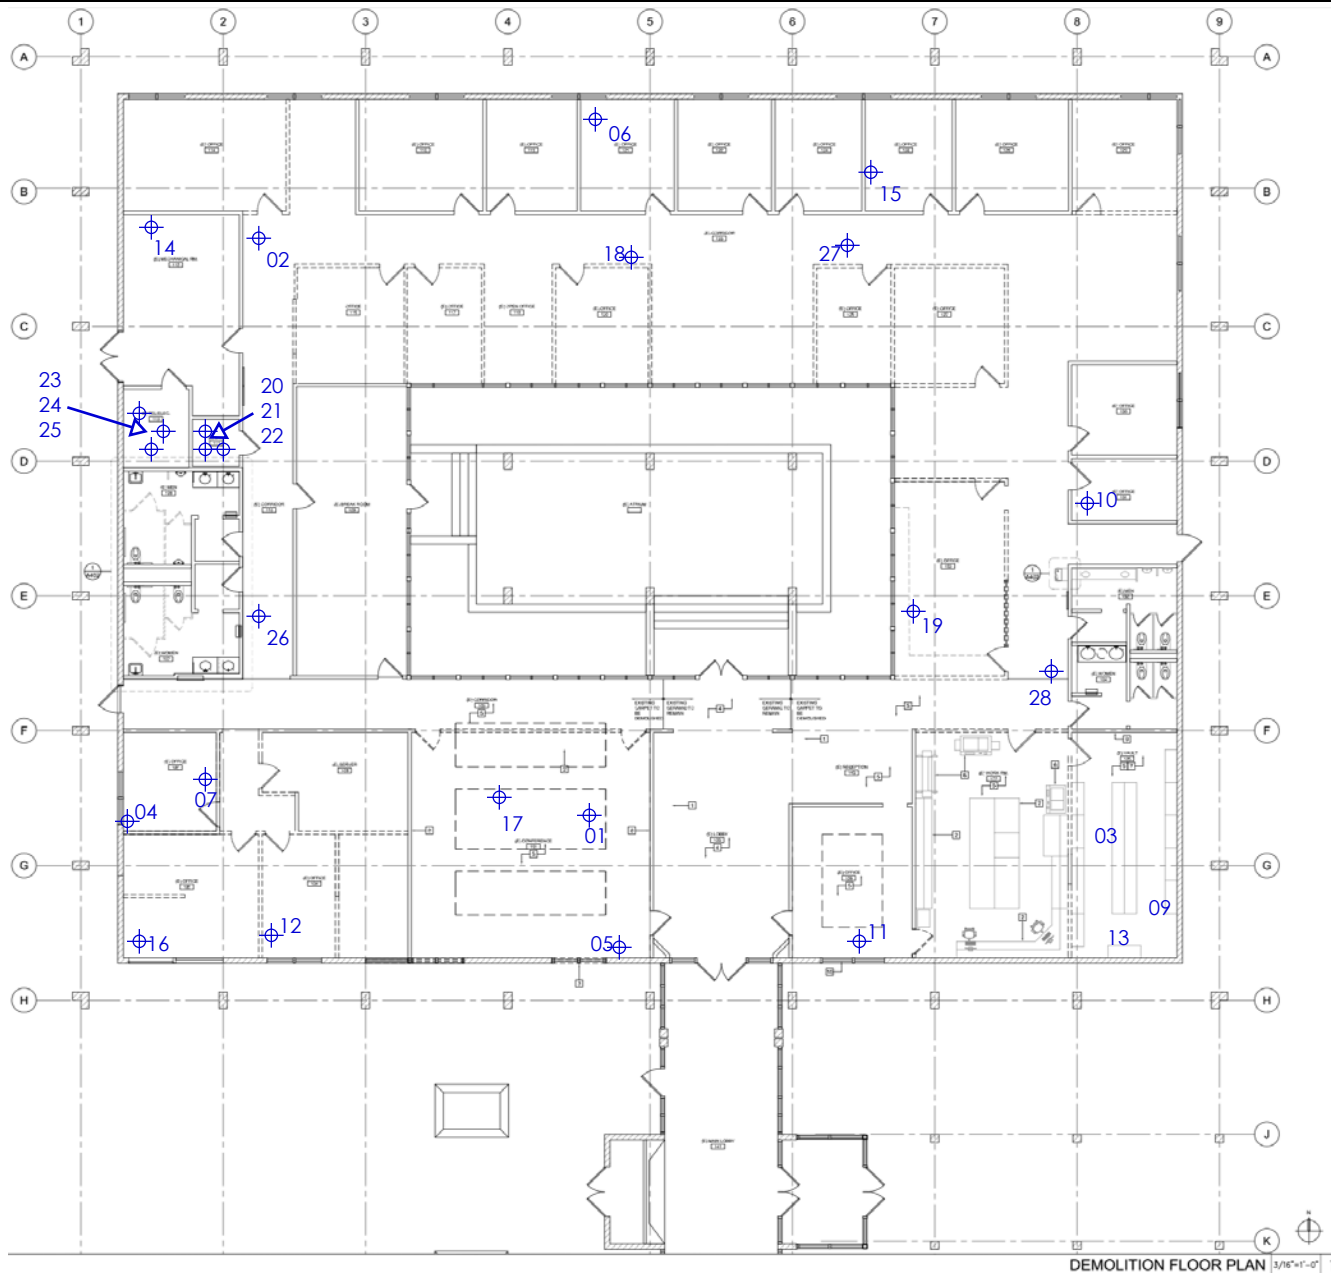
1

⊕ Indicates Approximate Sample Location
