# Allen McColloch Pipeline Status Update

Municipal Water District of Orange County  
Workshop Board Meeting

January 3, 2024

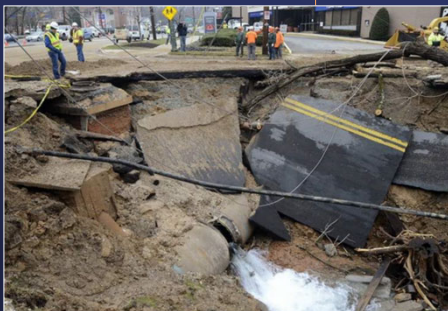
Maryland PCCP Rupture (2013)

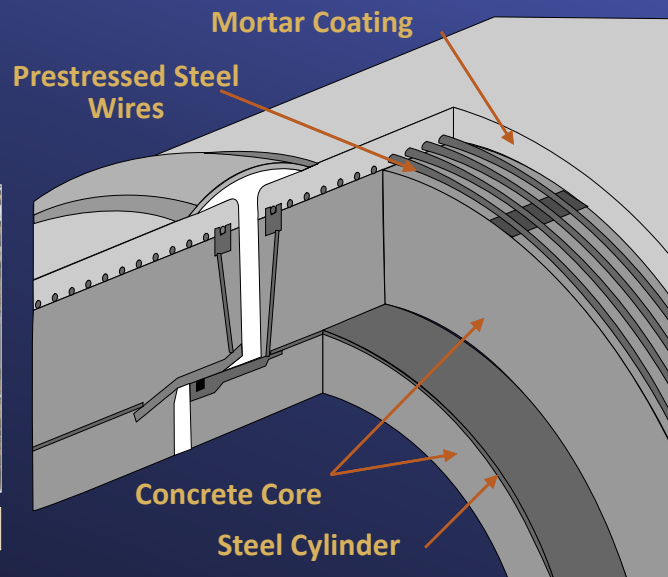
Slide 2

## Prestressed Concrete Cylinder Pipe

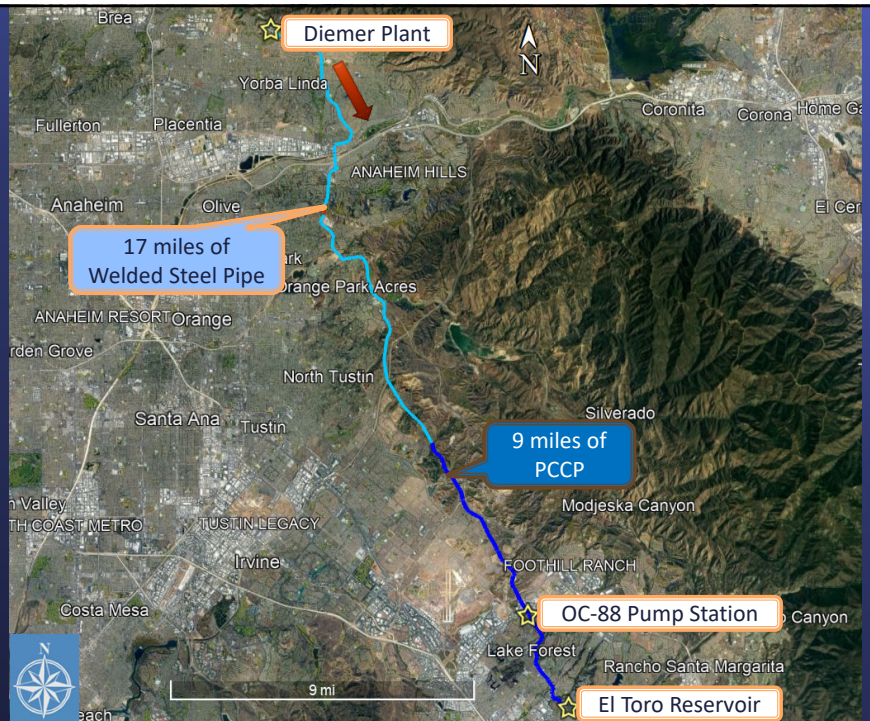
Diemer Water Treatment Plant to El Toro Reservoir

- Acquired in 1995
- Length: 26 miles
  - Steel: 17 miles
  - PCCP: 9 miles
- PCCP diameters from 54" to 78"

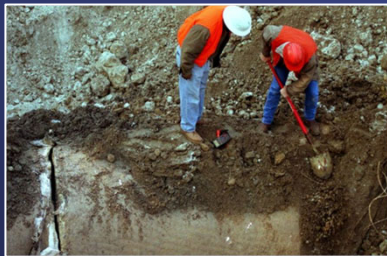
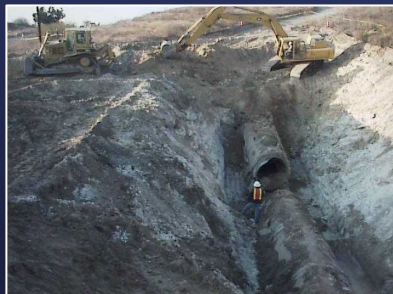
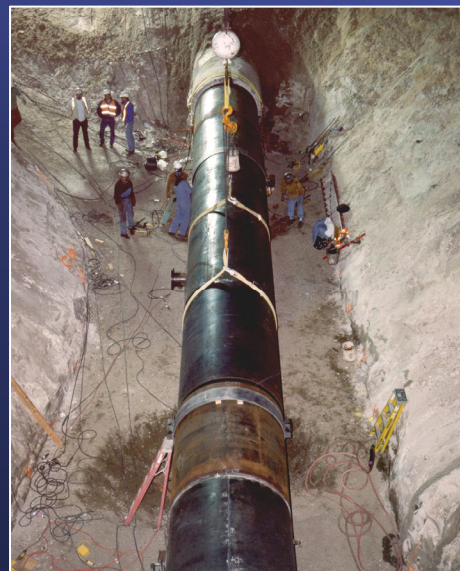
Slide 6

## Allen-McColloch Pipeline Failure – 1999

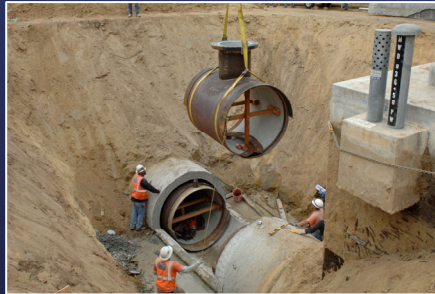
2010 AMP  
Steel Lining

- Apr. 2000 – Rehabilitation of 18 pipe segments
- Feb. 2001 – Replacement of 1 pipe segment
- Oct. 2001 – Carbon fiber lining 8 pipe segments
- May 2010 – Steel lining of 6 pipe segments
- Nov. 2020 – Steel lining of 20 pipe segments

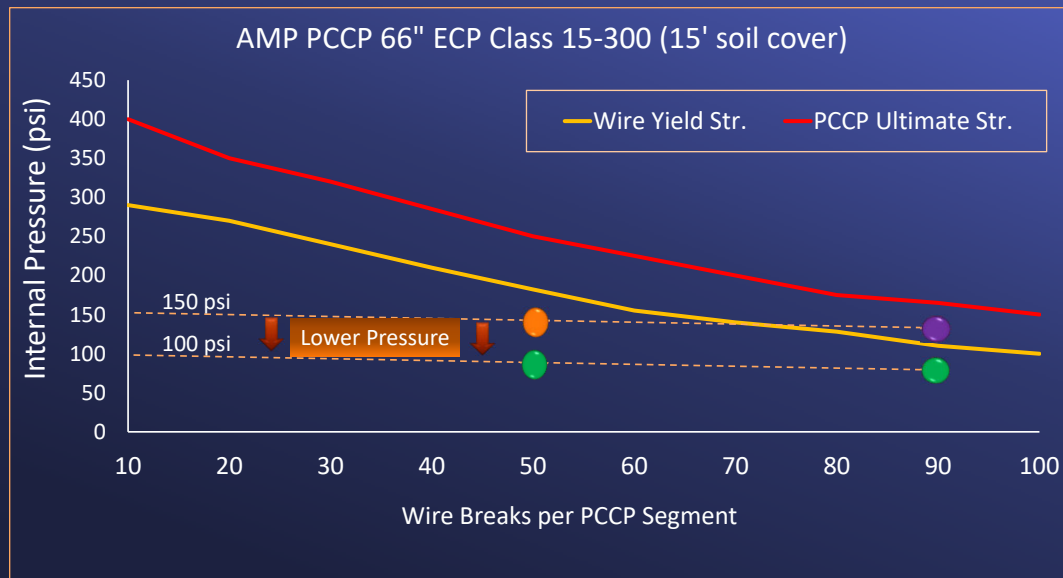
Slide 9

## PCCP Condition Assessment - Typical Risk Curve
