June 28, 2017

**Subject:   *Seismic Assessment of the South Emergency Operations Center***  
***26081 Via Pera, Mission Viejo, CA 92691***  
IDS Job Number: 17S020

Per your request, IDS Group, Inc. (IDS) has performed a seismic assessment of the South Emergency Operations Center (EOC) for the Water Emergency Response Organization of Orange County (WEROC) located at 26081 Via Pera in Mission Viejo, California. This letter presents our opinions, observations, and conclusions based upon our assessment.

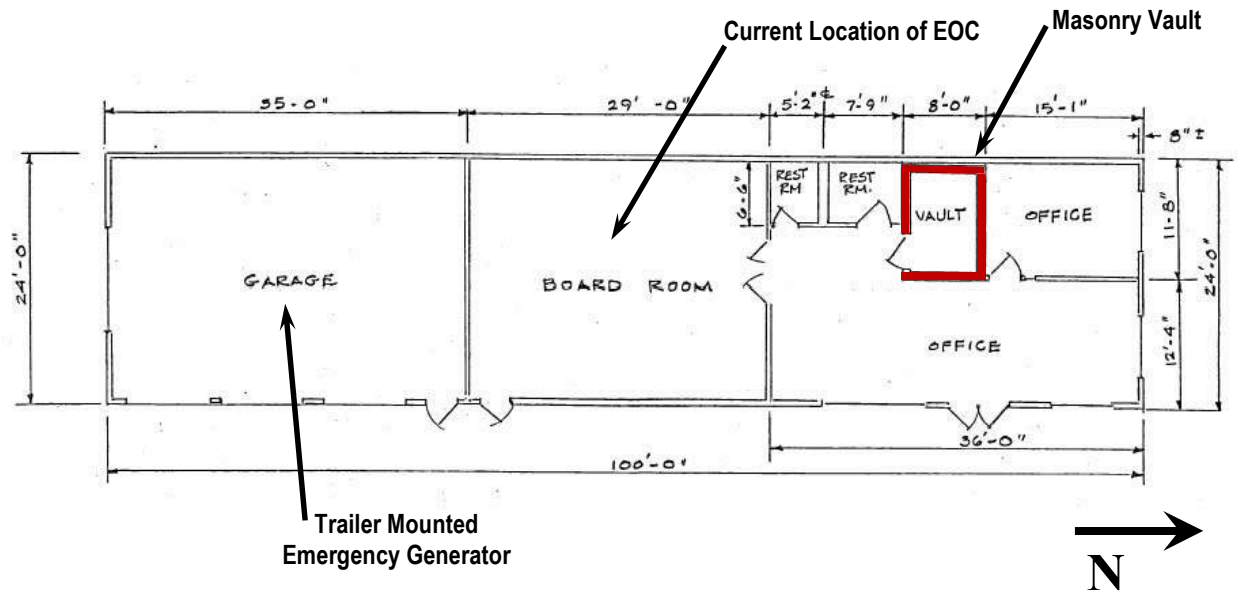
**Figure 1: Basic Building Layout Plan**

The EOC building is a one-story manufactured steel building with overall dimensions of 24 feet by 100 feet in plan and 12 feet in height at its eave [Photos 1 to 6]. The available record drawings [Ref. 1], and placards on the building indicate that it was manufactured by Soule Buildings. Based on these record drawings, the building was designed in 1977. Based on information provided by WEROC, it was constructed in 1981. The building is partitioned into two distinct areas; an unfinished garage area is located in the south third of the building and the EOC and office areas with interior finishes are located at the northern two-thirds of the building [Figure 1]. A concrete masonry vault structure exists in the northwest corner of the building. The building sits on a level pad at the base of a low hill to the south with a small valley for a water storage tank to the east. Several other buildings are located on this site but are located across an asphalt paved drive aisle from this building.

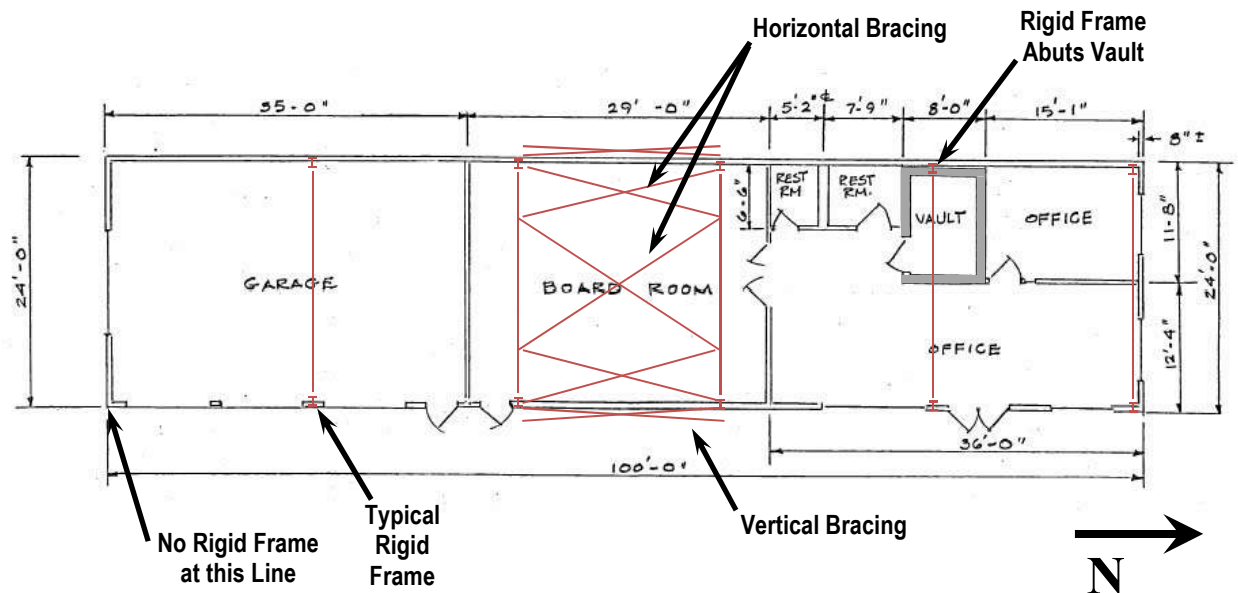
**Figure 2: Layout of Lateral Force Resisting System**

The building's lateral force resisting system [shown in Figure 2] includes one bay of horizontal tension-only rod bracing at the middle of the building for resisting forces in the longitudinal direction. That bracing is intended to collect lateral forces from building elements and transfer them to the east and west sides of the building where vertical tension-only strap bracing is connected to the building's frame columns. This strap bracing then transfers the lateral forces down to anchor bolt connections at the bases of rigid frame columns for transfer to the concrete slab on grade foundation. In the transverse direction of the building, five regularly spaced rigid frames serve to collect and resist the building's lateral forces. These rigid frames have bolted beam to column connections and pin-based columns with anchor bolts that transfer the lateral forces to the concrete slab on grade foundation.
