**Report on the
Conceptual Seismic Retrofit Study
of the
MWDOC Administrative Building
18700 Ward Street, Fountain Valley, California**

IDS Project Number 17S020.01

February 26, 2018
(2/26/2018 update)

CONCEPTUAL SEISMIC RETROFIT STUDY MWD OC ADMINISTRATIVE BUILDING FOUNTAIN VALLEY, CA

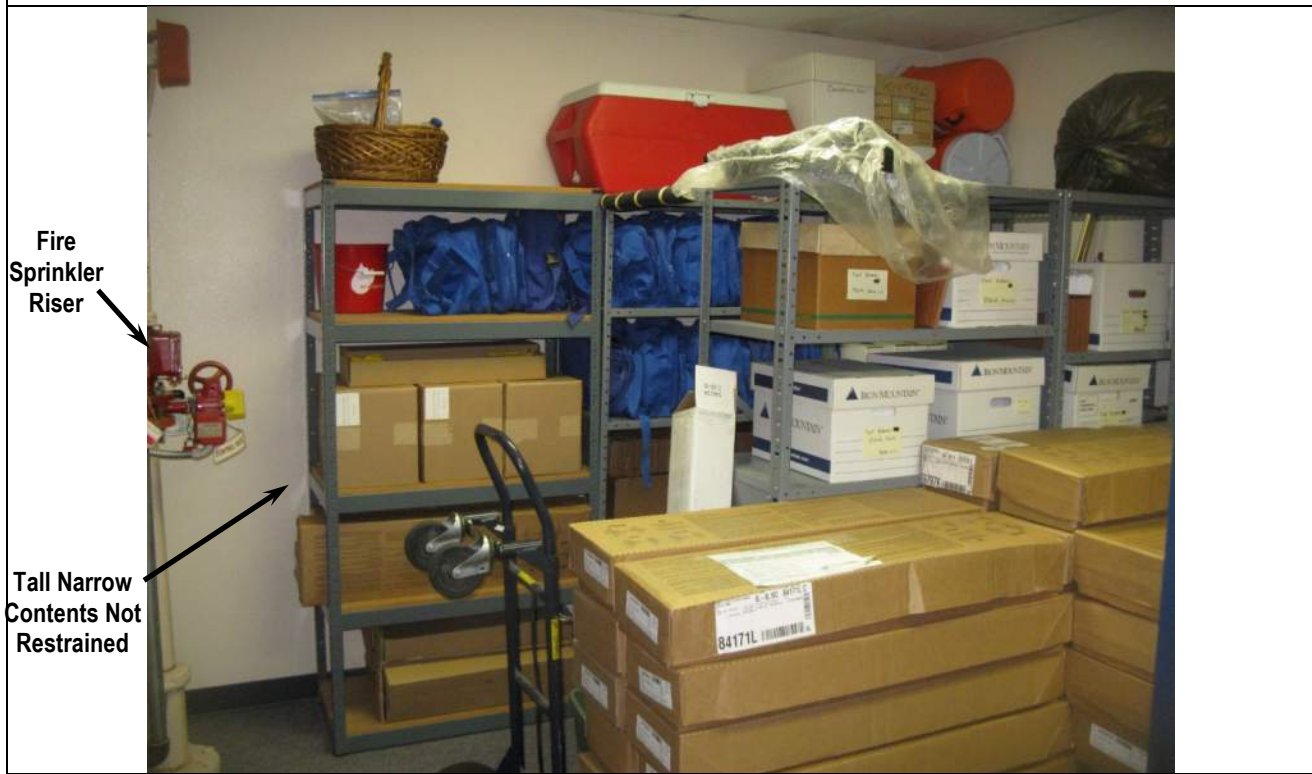
Photo 24: Storage Room at Southeast Corner

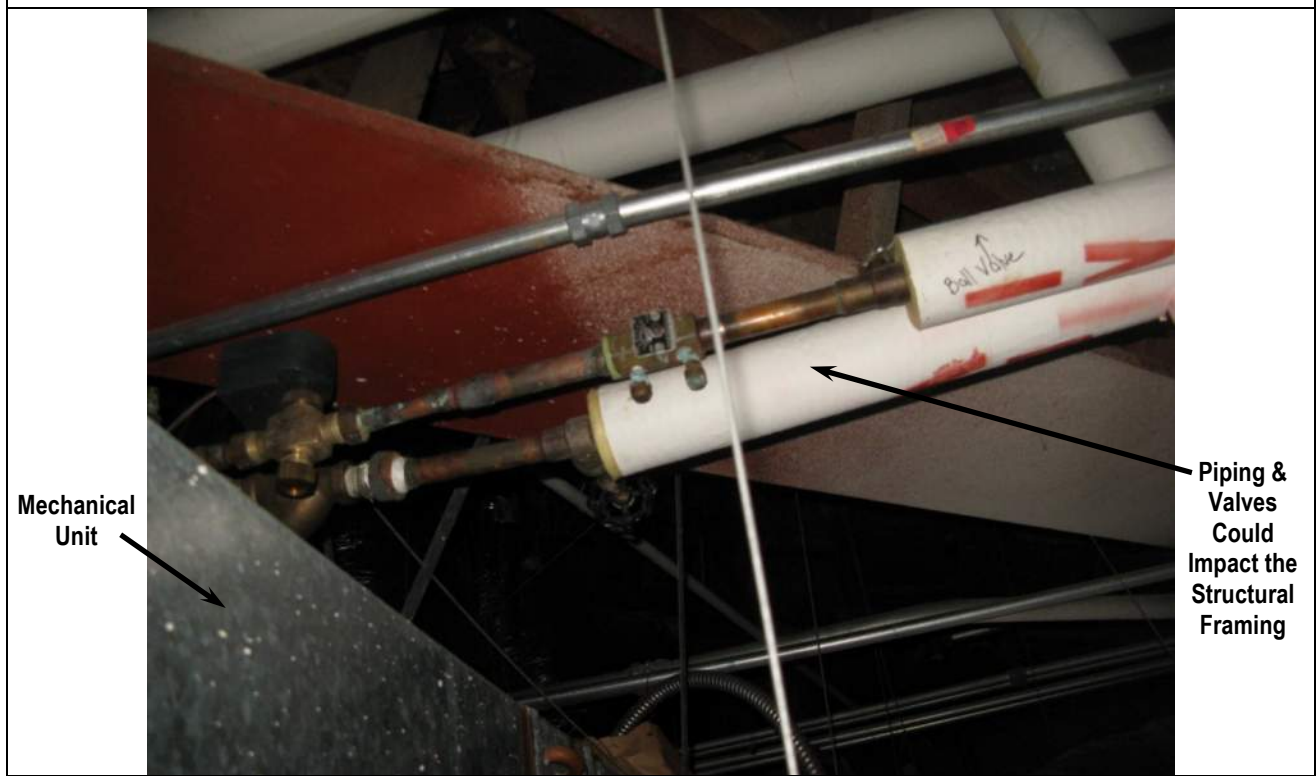
- Piping Not Sufficiently Anchored – Piping is insufficiently supported and braced, especially in the ceiling above the computer server room where line breakage could flood the computer equipment [Photos 25 and 26]. Photo 26 shows some small diameter lines that have the potential to impact the structural framing due to the swaying or movement of the mechanical unit above the ceiling of the computer room. This type of impact could cause a leak. Fire sprinkler lines exist both protruding through the suspended ceiling of the computer room and

Photo 26: Water Piping in Ceiling Above Computer Room
